## Hydro-acoustic Survey and Edge-detection method in Investigation of a Passenger Vessel Accident in East Java, Indonesia

Hendra Kurnia Febriawan<sup>1\*</sup>, Yudo Haryadi<sup>1</sup>, Aleik Nurwahyudy<sup>2</sup>

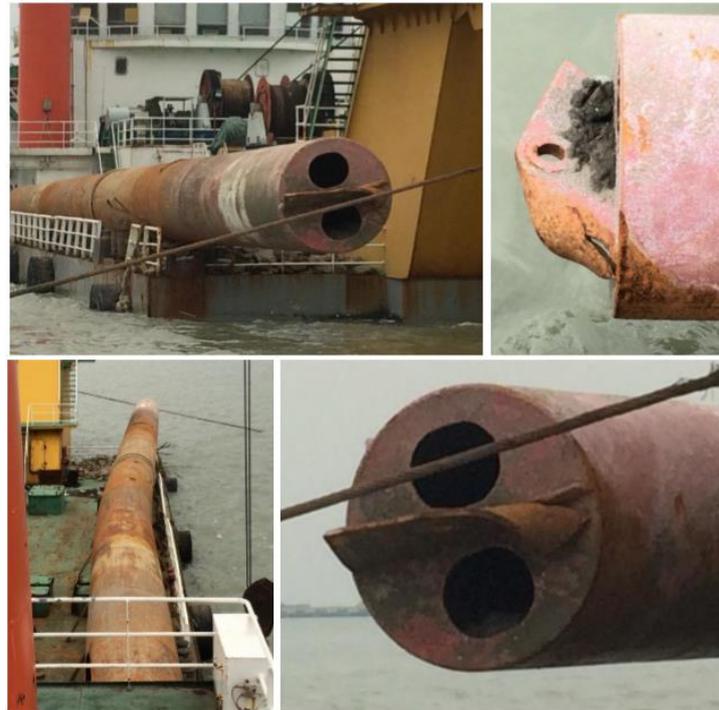
The fifth object found by side-scan sonar (Table 1) was suspected as the main cause of vessel collision. On 24 December 2015, it was found a spud pile at the location of  $7^{\circ} 10' 28.89''$  S/  $112^{\circ} 41' 36.01''$  E (approximately 600 m from the fifth object coordinates) and then was recovered from the seabed (KNKT, 2015). It was reported that the vessel draft when departed was 6 meters below the water surface. Considering that the depth of the crash location is around 20 m, it means there was a water column clearance around 14 m in that location. The fifth object had dimension 14.9 m of height and 1.5 m of width, which was fitted with that information. In addition, the recovered spud pile had dimension 1.8 of diameter and there was damage in eyepatch and bent of 15 m from the top of the eyepatch (Figure 4). It was suspected that the cause of the damage was the collision with the vessel hull and resulting in a severe rip of the vessel hull.

**Figure 4.** A damaged eyepatch and spud pile

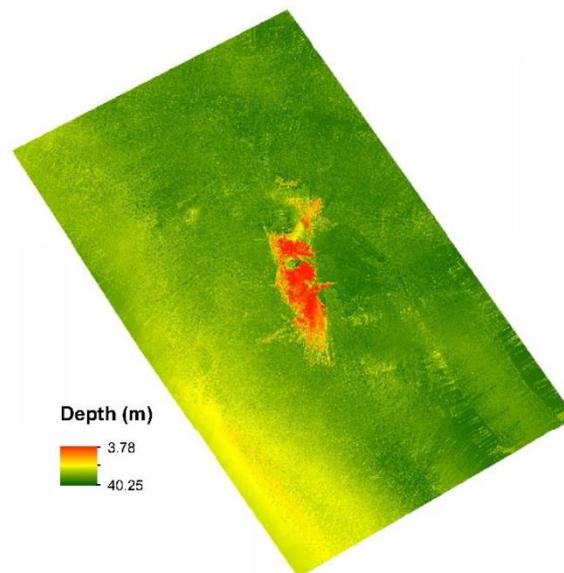
In addition, the multibeam survey carried out in the wreck location produces a high-resolution digital elevation model (DEM) as can be seen in Figure 5. It can be noticed that the depth at wreck location is relatively flat with depth varies from 16 to 30 m. The wreck's body was located only 3.8 m below the water surface. Albeit the wreck shape cannot be portrayed clearly, its shape (elevation) can be differentiated from the seabed surroundings. Thus in object detection, slope analysis is common to be used for DEM bathymetry. On the other hand, in the side-scan sonar imagery that does not contain depth information, the object detection is subject to image processing domain. Therefore, edge detection is more suitable to be used for side-scan sonar imagery.

**Figure 5.** Digital elevation model (DEM) bathymetry of the wreck

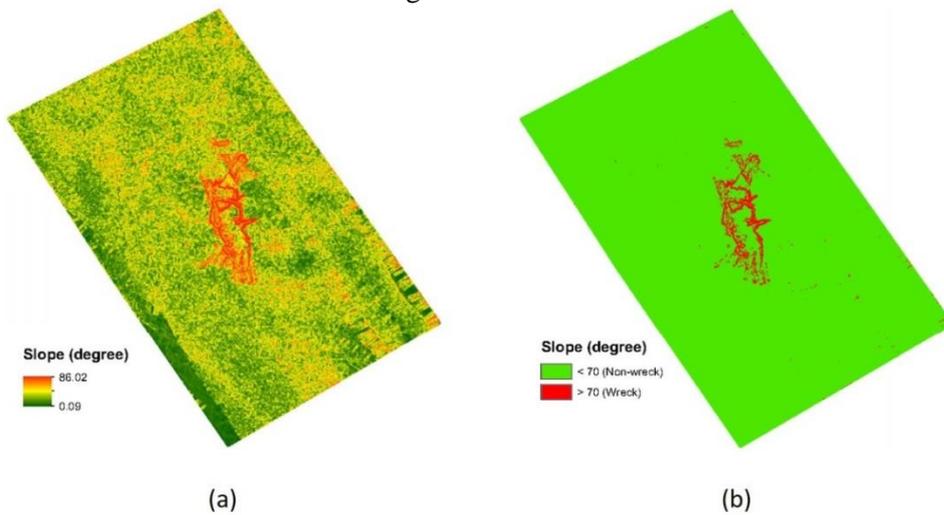
The experiment of slope analysis and image segmentation were applied to the wreck image (both DEM and side-scan sonar image) of MV Wihan Sejahtera. The slope result of DEM (figure 6(a)) indicates that the area of the wreck has a relatively low slope (flat area). The figure 6(a) also depicts that the wreck produces a high slope (approximately  $70^{\circ}$  to  $86^{\circ}$ ). Thus, classifying the image based on that degree of slope could reveal the boundary of the wreck. The classification process was using the classification tool in ArcGIS and the result is shown in Figure 6(b). The classified image, which contains wreck and non-wreck classes, depicts the wreck pronouncedly than the slope image produced previously. Although there are a few miss-classified pixels of seabed that classified as wrecks, overall, the wreck class indicates a similar result with the boundary in the slope image.

**Figure 6.** (a) Slope feature of the DEM bathymetry, (b) Result of slope classification

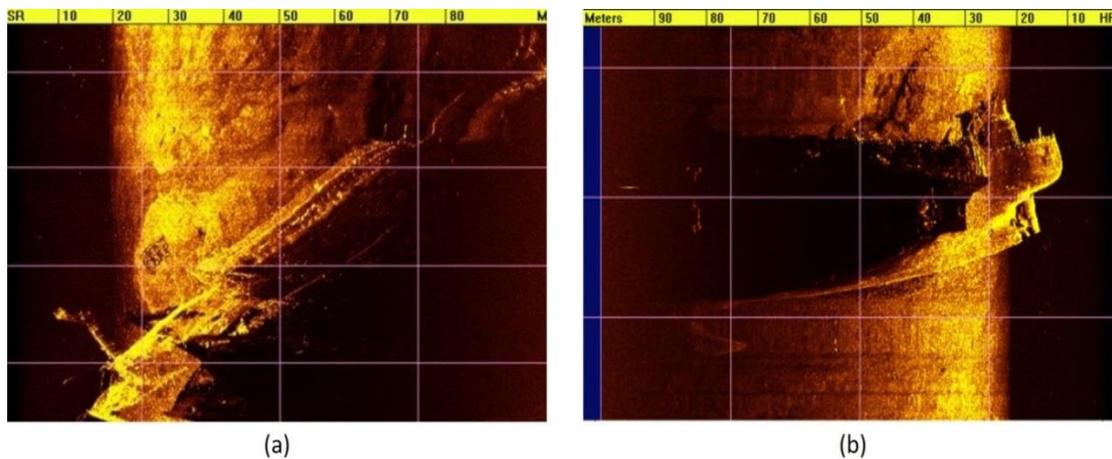
The sonar images (Figure 7) show that the wreck was skewed  $40^\circ$  to the starboard side of the vessel. This was resulting in starboard and hull sides of the vessel were embedded in the seabed and cannot be portrayed in the image. Consequently, visual examination and interpretation of the rips became not possible, though the wreck had been portrayed in detail in

the sonar image. All of the vessel’s parts are still completed meaning it sank smoothly without any crash with other hard objects. In the image, the vessel’s bow and stern are located in half of the water column (dark side) and can be interpreted that its body lied in half of the depth in the location. Figure 8 depicts edge-detection results that consists of grayscale images, smoothed images, and edge detection images. Smoothed images (Figure 8 (b) & (e)) show that the objects of seabed and wreck are seamless with sharper in the object’s boundaries. It also can be noticed that small speckles in the images have been removed. Hayes & Ho (2004) explained that side-scan sonar images contain clear noises (salt and pepper), which can lead to miss-detected of the edge of the vessel. Although Gao *et al.*, (2010) argued that a combination of median filter and Sobel filter could not remove the noises in the common images effectively, the median filter also shows a good result applied to side-scan sonar image in this study. Sobel filter that was used for edge

**Figure 7.** (a) Sonar image of the wreck showing the bow of the vessel, (b) Sonar image of the wreck showing the after end of the vessel

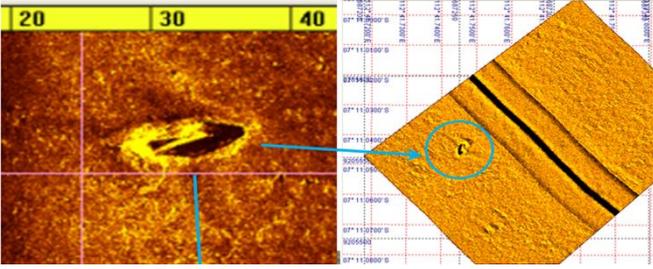
7°11'0.3"S, 112°41'44.7"E  Depth: 19 m	5m x 4m x 2m
2

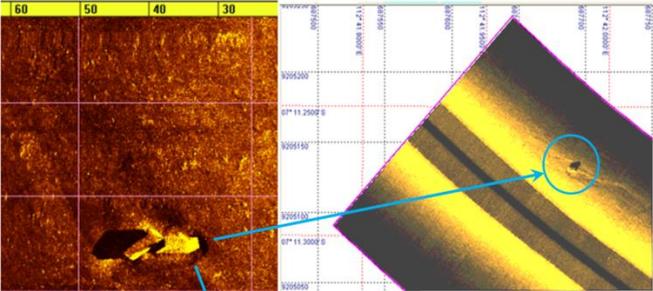
7°11'16.2"S, 112°41'59.4"E  Depth : 17 m	5m x 2m x 2m
3

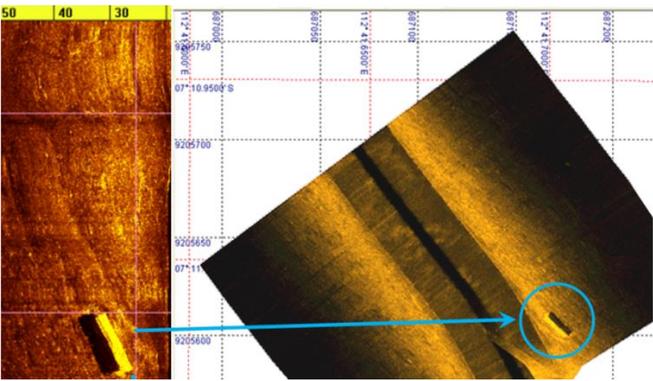
7°11'15"S, 112°41'42.12"E  Depth : 20 m	7m x 2m x 2m  Suspected as a container
4

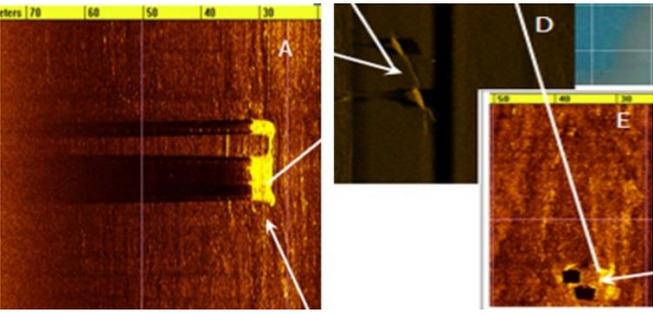
7°10'25"S, 112°41'17"E	length of 11 m with 7 m of connecting support
5

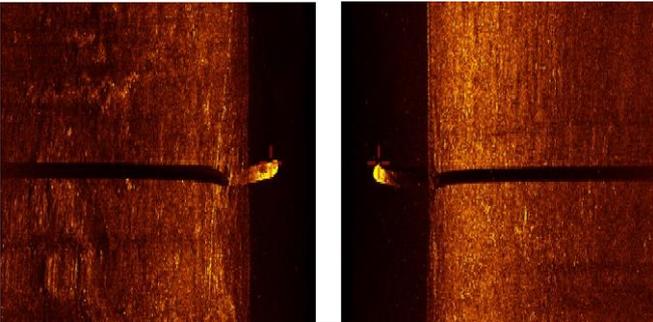
7°10'24.70"S, 112°41'16.82"E	14.9 m of height and 1.5 m of width

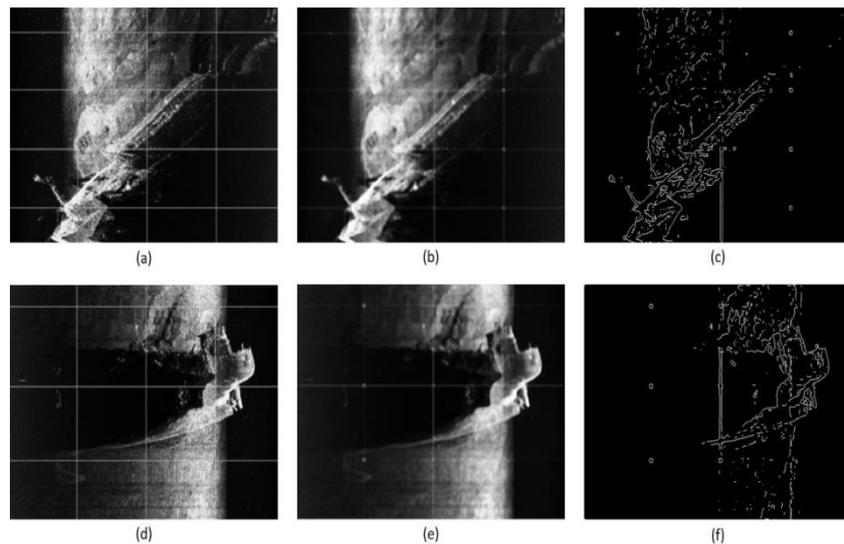
detection indicates that this filter worked well to detect the edge of the wreck (Figure (c) & (f)). The wreck’s shape in the segmented images is also consistent with its shape in the sonar image. The grayscale images of side-scan sonar have a limitation of the existing rectangular grid, which should be removed for image processing purposes. This is resulting in some linear strips remain in the segmented images. In addition, there are some miss-detected features in the results, which are probably caused by a high-saturated seafloor because of strong signal returns near the nadir. This also has been explained by Hamill *et al.* (2018) that in 8-bit quantization of the sonar image is not adequate enough to captivate the dynamic range of backscatter signal, particularly in the off-nadir area. Thus post-processing stages, which are detail explained in Blondel (2009), are compulsory in order to get a sufficient result of the sonar image for further analysis.

**Figure 8.** Result of edge-detection: (a) & (d) grayscale images of the wreck, (b) & (e) smoothed images of the grayscale images (a, b), (c) & (f) result of edge-detection
