## Strength Analysis and Repair Strategy of Aged Steel Jetty Pile

Raditya Danu Riyanto<sup>1\*)</sup>, Nur Syahroni<sup>1)</sup>, Yeyes Mulyadi<sup>1)</sup>

<sup>1)</sup>Department of Ocean Engineering, Institut Teknologi Sepuluh Nopember, Surabaya 60111, Indonesia

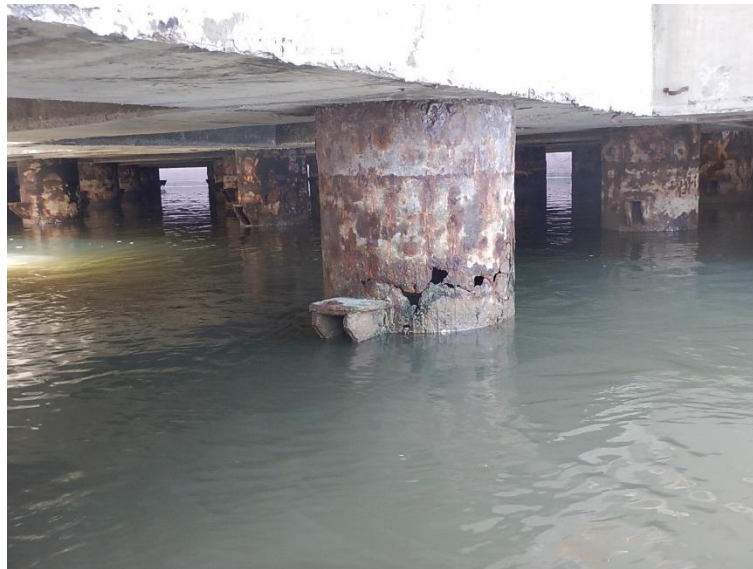
Figure 1 shows the existing jetty condition that is in severe corrosion. The jetty is intended to be repaired and renewed to extend its service life up to 20 years. With the limited repairing budget, the strength analysis and repair strategy must be carried out to provide the best possible result.

Figure 1. Aged Steel Pile Jetty in Severe Corrosion

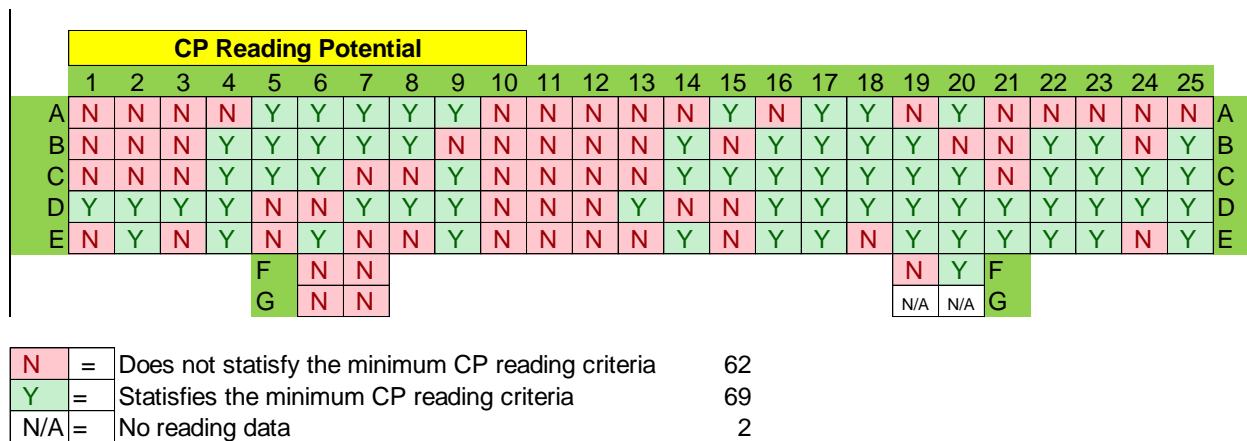
Based on applicable codes and standards, namely DNV-RP-B401, CP readings must be in the range of -1050 mV to -800 mV [13]. The more negative Readings than -1050 mV are included as over-protection, which causes damage to structural members. Meanwhile, a more positive reading than -800 mV is included as an under-protection that can cause corrosion to structural members. Figure 4 below explains the results of the CP reading mapping. Mapping is done by giving a red color to the pile that does not meet the protection criteria. While the green color is given to piles that meet the protection criteria.

Figure 4. CP Potential Survey Results

Improvement of the corrosion protection system (CP) is also carried out by installing a new system that protects the pile section underwater. Meanwhile, the piles above the waterline, especially in the splash zone, are equipped with composite wrapping and coating to avoid corrosion, as shown in Figure 15.

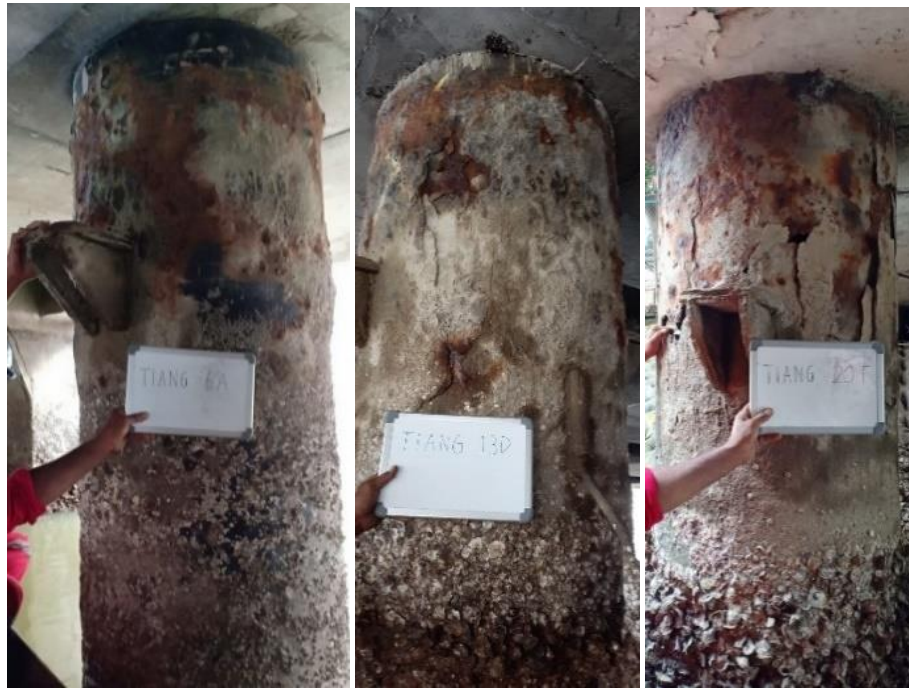
The selection of jetty piles that undergo the UTM survey is based on the inspector's justification. The corrosion inspector assessed the level of corrosion visually and then chose the pile. Figure 6 gives the visual example of a jetty group that did not experience damage due to corrosion. Hence UTM was not chosen for this group. Pile number 6A is an example of the pile facing the sea. Pile number 20F represents the pile in the trestle area, while pile number 13D gives an overview of the pile's condition facing the land.

Figure 6. Visual Inspection of Relatively Healthy Jetty Pile (from left to right: 6C, 13D, 20F)

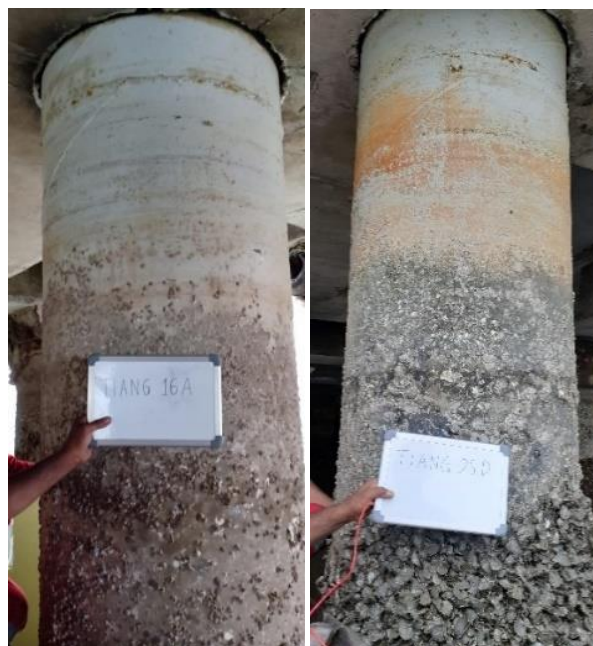
The pile group that had undergone repairs was not chosen for UTM. Figure 7 gives a visual example of the group. Pile number 16A gives the example of a condition for the pile facing the sea, while pile number 25D for the pile facing the land. There are no piles repaired in the trestle area.

Figure 7. Visual Inspection of Previously Repaired Jetty Piles (from left to right: 16A dan 25D)

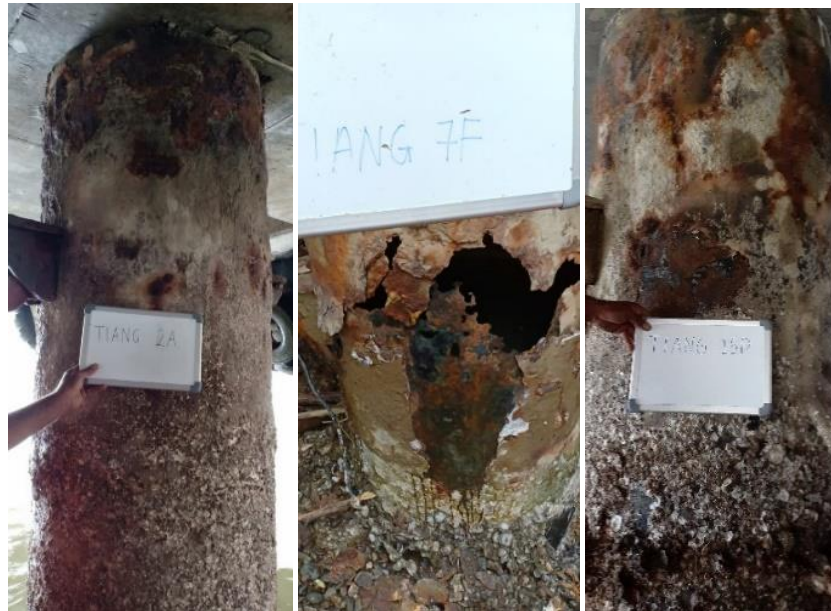
The two groups above can be compared visually with Figure 8, which provides visual inspection examples of piles that fall within the inspection criteria. Pile number 2A gives the example of heavily corroded piles facing the sea, pile number 7F presents a picture of jetty piles condition in the trestle area, while pile number 15D represents jetty side facing the land.

Table 2 provides an example of UTM results on pile number 2A. The remainder of the inspection result gives a relatively similar result that there are excessive corrosion and holes in the piles.

Figure 8. Visual inspection of heavily corroded jetty piles (from left to right: 2A, 7F, dan 15D)

The repairs are carried out by the method of patching. This method is done by firstly depriving the part of corroded piles. Then two parts of replacement plates are sleeved onto the piles with a length of 2 meters from the pile cap. Finally, the parts are welded to generate a ‘patch’ for the damaged pile. The cross-sectional dimension of the part is equal to the initial design criteria, 762 mm and 12 mm for diameter and thickness, respectively. Yield strength was reduced to 85% from initial yield strength to accommodate the uncertainties and the possibility of strength reduction from the patched piles. The yield strength of the piles that are found have been repaired before this analysis are also reduced. The illustration of the patching method is shown in Figure 14.

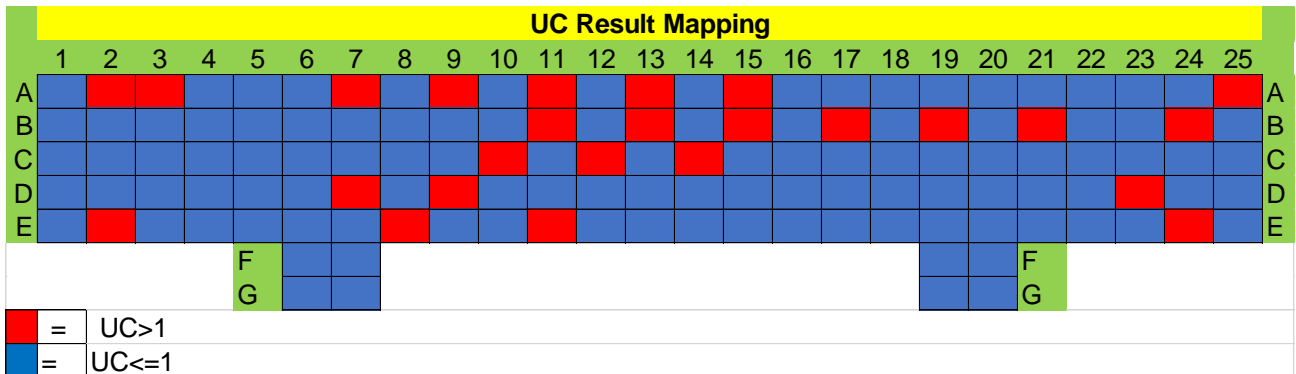
The required UC value for each of the piles is below 1.0. Whenever piles with UC exceed 1.0, they are categorized as ‘damaged’ so that the repairing strategy is needed. Based on the analysis performed, there are 25 out of 133 piles are categorized as ‘damaged’ piles. These 25 piles are the numerically modified stiffness piles based on the inspection result. Figure 13 below shows the mapping of the damaged structures. From the figure, we can see that the majority of the damaged structures are the seaside-facing piles. The most considerable portion of the stress is caused by the vessel berthing force and the environmental loads.

Figure 13. Damaged jetty piles mapping
