EVALUATION OF ACCESSIBILITY AND INCLUSIVE ARCHITECTURE COMPLIANCE AT TAMAN ISMAIL MARZUKI LIBRARY (TIM), JAKARTA

MODUL vol 26 no 1, issues period 2026

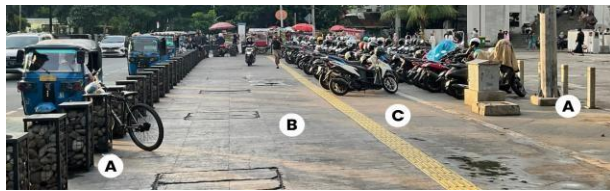
As shown in Figure 2, pedestrian access to the TIM from Cikini Raya Street begins with an 8 meter sidewalk and a 15.5-meter front plaza, featuring a yellow guiding block for individuals with visual impairments (C).

Figure 2. Tactile guiding block at the front plaza of TIM (Author 2025)

The surface is flat and non-slip, running parallel to the plaza without any steps (B). Bollards (A) in a block shape are placed around the sidewalks and plazas to create a physical barrier against vehicles, enhancing circulation and security (Nakamura & Yoshioka, 2021) The front plaza of the TIM, measuring 23.5 meters from the curb to the building's front door, is also free of physical barriers and includes a wheelchair-accessible entrance without physical barriers.

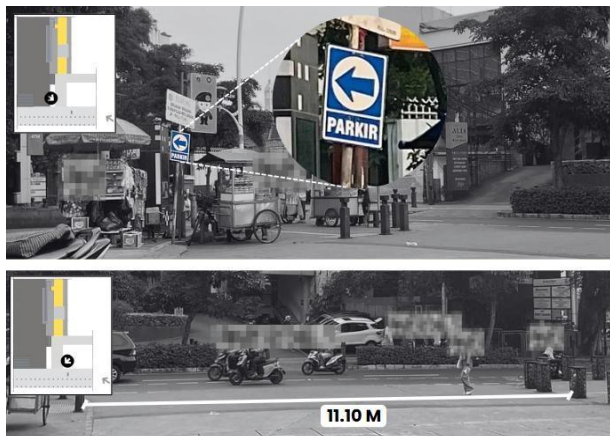
Motorized vehicle access to the parking lot is marked by clear and uniform signage along the 11.1 m wide path (Figure 3). Upon arrival, drivers can take a ticket from an automatic machine equipped with buttons and an information screen; the barrier opens automatically, guiding the vehicle according to the system's instructions.

Figure 3. Visual directions and vehicle entry circulation width TIM, Jakarta (Author 2025)

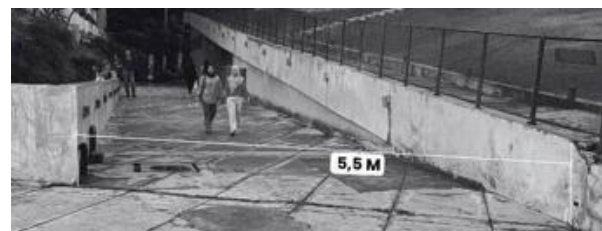
Figure 5. Main entrance access to ramp and elevator of TIM building (Authors 2025)

However, there is no guiding block leading to the Ali Sadikin building, which is only available in the front

plaza, resulting in suboptimal navigation for the visually impaired (Fadhllillah, 2023).

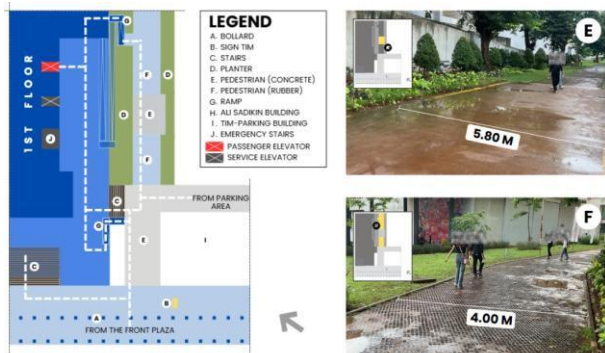
Figure 6. Paths with 2 different layers (Author 2025)

The side entry track (E) utilizes grid-patterned concrete for drainage purposes, but the narrow drainage gaps may cause wheelchair wheels to become trapped. The main ramp track, measuring 4 meters in width, is covered with hollow rubber. However, it becomes slippery (F) and unstable during rain. The transition to the 5.8-meter wide smooth concrete surface is also slippery when wet (E). This observation aligns with findings indicating that cement concrete surfaces exhibit increased slipperiness when wet (Sjahdanulirwan & Tatang Dachlan, 2018).

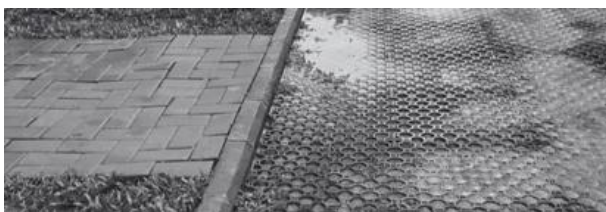
Figure 7. Transition surface rubber and paving blocks on the path to the ramp Ali Sadikin building. (Author, 2025)

The subsequent area consists of paving blocks with uneven elevation, which heightens the risk of wheels becoming stuck and slipping in wet conditions (Figure 7), (Ningrum & Wahyuhana, 2023).

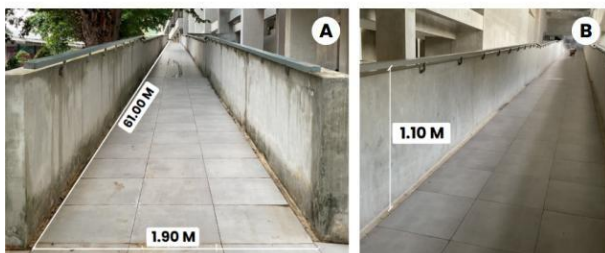
Figure 8. Outdoor Ramp to 2nd floor (Author 2025)

The vertical ramp, measuring 61 m in length and 1.90 m in width, complies with the maximum ramp slope requirement of 1:12 as specified in Permen PUPR No. 14/PRT/M/2017. To enhance user safety and independence, iron handrails standing 1.10 meters tall (B) are installed on both sides of the ramp (Rahardjo et al., 2023). However, the lack of a roof or anti-slip coating results in a slippery surface during rainy conditions. According to Kim et al., (2014) research, the combination of slope and contaminants like water heightens the risk of slipping on ramps.

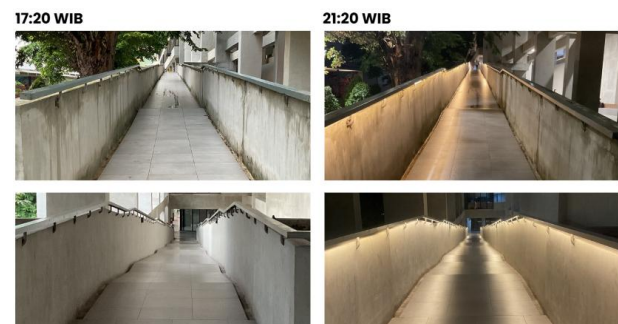
Figure 9. Left: ramp condition at 17: 20 WIB; Right: ramp condition at 21: 20 WIB (Author, 2025)

The illumination along the ramp leading to the second floor is quite adequate (Figure 9). Users can easily comprehend the signs, identify the circulation path, and spot potential obstacles without experiencing glare, which significantly enhances their sense of safety and visual comfort during nighttime. According to Liu et al., (2022), the perceived quality of street lighting influences pedestrians' perceptions of visual safety and comfort.

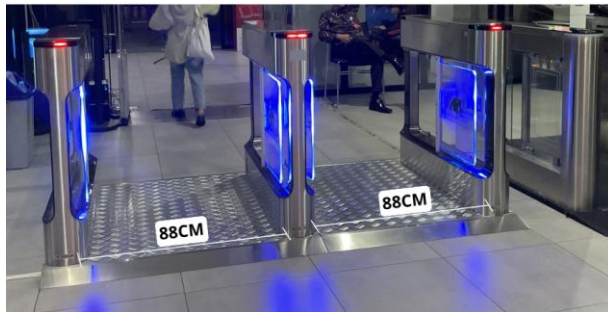
Access to the main library area on the third floor begins through a 1.85 m-wide entrance door, followed by a security gate measuring 88 cm in width and a ramp that is 10 cm high (Figure 10).

While the ramp is technically wheelchair accessible, the short length reduces both comfort and safety for users. Studies indicate that access ramps,

especially those located at security doors or with constrained designs, can pose increased risks for wheelchair users due to the higher likelihood of slipping and difficulty in maintaining balance (Kapsalis et al. 2024).

Figure 10. Second door with ramp after main door (Author 2025)

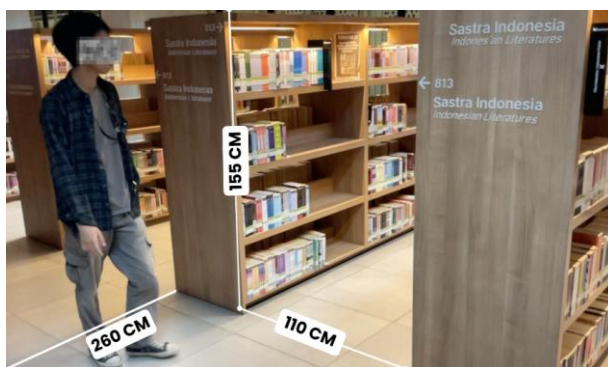
Figure 11. Main circulation width, shelf circulation and shelf height (Author 2025)

On the 4th floor, the main corridor measures 2.60 m in width, and the space between the bookshelves is roughly 1.10 m (see Figure 11). This generally satisfies the minimum space requirements for wheelchair users and other visitors. The bookcase stands at a height of 1.55 m (refer to Figure 11), allowing users to easily view and reach

most book collections. However, it lacks guiding blocks or Braille labels as shown in the figure. According to IFLA Equitable and Accessible Library Services Section (2024), tactile pathways should be incorporated into the design of internal public spaces to ensure navigation for visually impaired and elderly users.

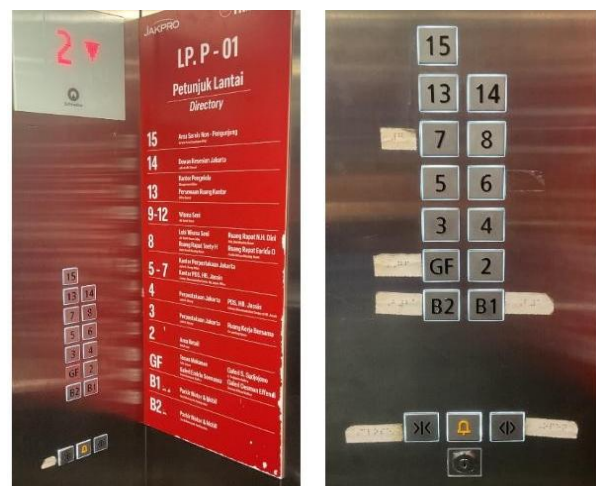
Access to the fifth floor remains problematic for wheelchair users because it relies solely on escalator circulation. There are no internal elevators connecting the upper library floors. However, the area includes effective informational cues: evacuation route instructions, exit signs, and category labels on bookshelves are clearly displayed and serve their navigational purposes well. Furthermore, the elevator buttons in the lobby are equipped with braille letters, which help visually impaired users navigate independently (see Figure 12). Examples of these features are summarized in Table 2.

Figure 12. braille letters on elevator buttons (Author 2025)
