Media Komunikasi dan Pengembangan Teknik Lingkungan e-ISSN: 2550-0023

Analysis of Pore Water Pressure and Seepage During The Impounding Stage of Randugunting Dam

Illya Nur Fatimah¹, Wahju Krisna Hidajat¹, Narulita Santi^{1*}

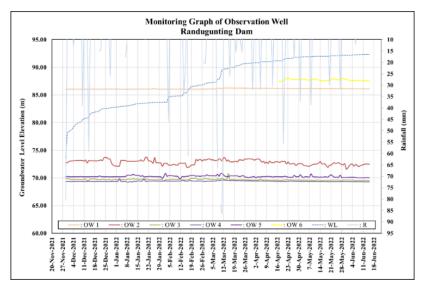
Figure 5. Randugunting Dam observation well monitoring graph

In the monitoring graph shown in Figure 5, groundwater level elevations are correlated with increasing reservoir water levels (WL) and rainfall intensity (R). Observation wells are installed at six points downstream of the dam. Based on the monitoring results, the average groundwater level elevation remains below the reservoir water level, indicating no signs of seepage. The relatively stable groundwater conditions suggest that reservoir water is not entering the observation wells. A slight increase in groundwater level is likely due to rainfall infiltration into the wells. Conversely, a significant rise in groundwater level without concurrent rainfall or reservoir level increase may indicate seepage in the downstream area of the dam. Therefore, inspections should be carried out in downstream area that exhibit signs of increased moisture, such as denser vegetation compared to surrounding areas.

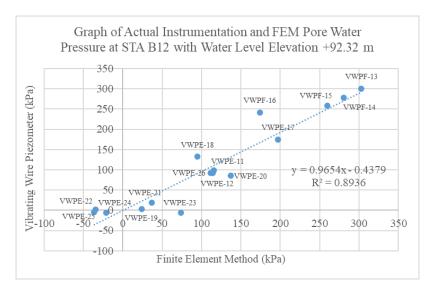
Figure 6. Graph of actual instrumentation and FEM pore water pressure at STA B₁₂ with water level elevation +92.32 m

Based on Table 5, the FEM analysis results show higher pore water pressure values compared to the actual instrumentation data. These elevated values are observed in VWPE-11, VWPE-12, VWPF-13, VWPF-14, VWPF-15, VWPE-17, VWPE-19, VWPE-20, VWPE-21, VWPE-23, and VWPE-26 resulting in positive deviations. A negative deviation in VWPF-16 is attributed to the influence of groundwater in the foundation, which causes the vibrating wire piezometer to register water flow as seepage, leading to elevated readings. In addition, the capacity of the vibrating wire piezometer, which can reach up to 500 kPa, may cause rapid increases in pore water pressure under saturated conditions. The negative deviations observed in VWPE-22, VWPE-24, and VWPE-25 are due to the high elevation of these instruments, where no water inflow is present. From the calculated pore water pressure deviations, an RMSE value of 35.26 was obtained. These findings are consistent with a study conducted at Raknamo Dam, East Nusa Tenggara (Kurniawan, 2021), which generally reported that pore water pressure values obtained through the finite element method are higher than those recorded by vibrating wire piezometers. According to the study, the FEM results can serve as a 'safe limit' for assessing the risks posed by excess pore water pressure. A significant rise in pore water pressure beyond this threshold, along with increasing reservoir water levels, may indicate the onset of piping within the dam embankment.

Based on the Figure 6, the relationship between pore water pressure values obtained from actual instrumentation and FEM analysis exhibits a positive correlation. This is indicated by the upward trend of the linear regression line, where pore water pressure values from both FEM and VWP increase concurrently. The results presented in Figure 6 show a correlation coefficient (R²) of o.89. According to Sugiyono (2016), this value falls within the 'very high' category, indicating a strong relationship between the two variables, with correlation range of 80–100%.

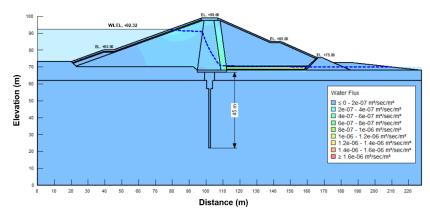
Figure 8. Modeling the addition of downstream seepage berm

Although the calibration results indicate that the seepage discharge falls within the safe category, the seepage estimated from the FEM analysis is relatively high, with a value of 0.01271 m³/sec, which may potentially lead to piping. Therefore, as a precautionary measure against the risk of excessive seepage as predicted by the model, 2 (two) technical recommendations are proposed for implementation in the event of an increase in actual seepage discharge.

The installation of a downstream seepage berm can balance uplift pressure and reduce excessive seepage flow within the permeable foundation layer at the downstream toe of the dam. This berm can be constructed in the toe drain area. Based on FEM analysis results (Figure 8), such an installation can reduce seepage discharge by approximately $0.00547 \text{ m}^3/\text{sec}$ or 43%, from the original value of $0.01271 \text{ m}^3/\text{sec}$ at a reservoir water level elevation of +92.32 m in STA B12 to $0.00724 \text{ m}^3/\text{sec}$. This assumes a permeability coefficient for the downstream seepage berm of $2.00 \times 10^{-2} \text{ cm/sec}$.
