*Regional Case Study***Analysis of Pore Water Pressure and Seepage During The Impounding Stage of Randugunting Dam****Illya Nur Fatimah<sup>1</sup>, Wahju Krisna Hidajat<sup>1</sup>, Narulita Santi<sup>\*</sup>**<sup>1</sup> Department of Geological Engineering, Faculty of Engineering, Universitas Diponegoro, Semarang, 50277, Indonesia<sup>\*</sup>Corresponding Author, email: [santinarulita@live.undip.ac.id](mailto:santinarulita@live.undip.ac.id)

Piping induced by seepage poses a significant risk to the stability of Randugunting Dam, located in Blora Regency, Central Java. This study aims to assess the geological and engineering geological conditions of the study area and to analyze the behavior of pore water pressure and seepage during the impounding stage. The methodology includes geological and engineering geological mapping, as well as field monitoring using instruments such as vibrating wire piezometers, v-notch, and observation wells. These field results were then compared with Finite Element Method (FEM) analysis conducted in GeoStudio SEEP/W 2018. The pore water pressure values derived from FEM analysis were generally higher than the actual values recorded by the piezomete

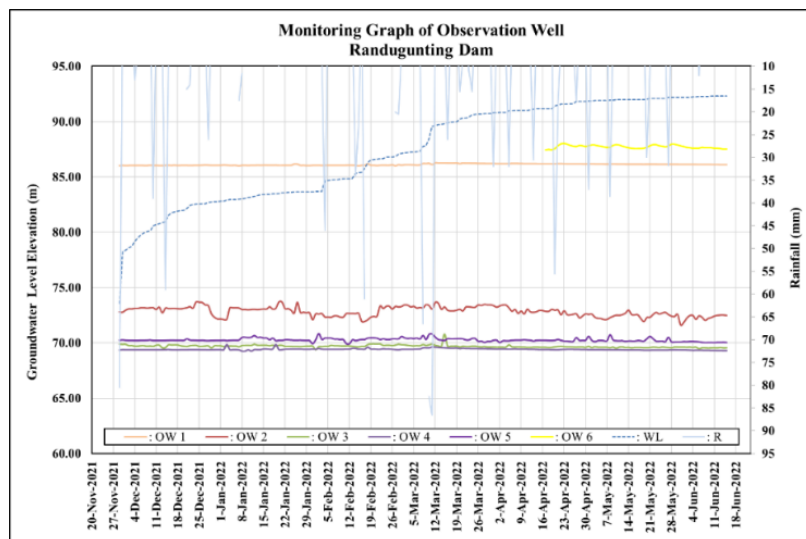
**Figure 5.** Randugunting Dam observation well monitoring graph

In the monitoring graph shown in Figure 5, groundwater level elevations are correlated with increasing reservoir water levels (WL) and rainfall intensity (R). Observation wells are installed at six points downstream of the dam. Based on the monitoring results, the average groundwater level elevation remains below the reservoir water level, indicating no signs of seepage. The relatively stable groundwater conditions suggest that reservoir water is not entering the observation wells. A slight increase in groundwater level is likely due to rainfall infiltration into the wells. Conversely, a significant rise in groundwater level without concurrent rainfall or reservoir level increase may indicate seepage in the downstream area of the dam. Therefore, inspections should be carried out in downstream area that exhibit signs of increased moisture, such as denser vegetation compared to surrounding areas.

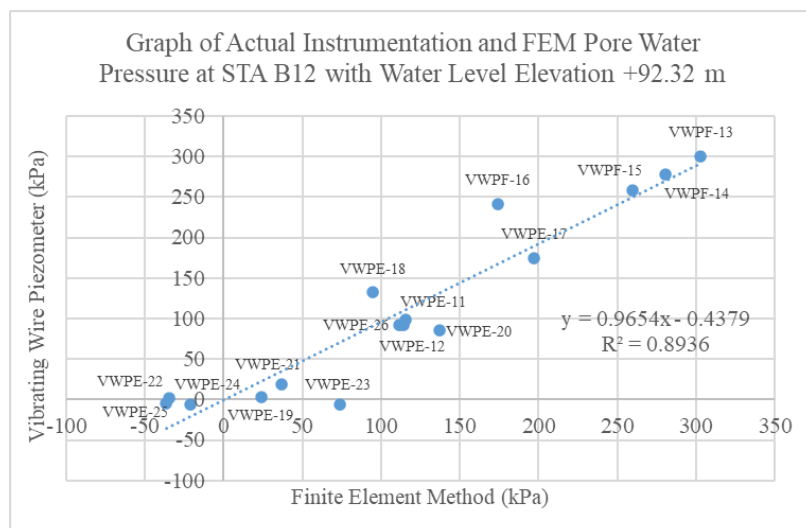
**Figure 6.** Graph of actual instrumentation and FEM pore water pressure at STA B12 with water level elevation +92.32 m

Based on Table 5, the FEM analysis results show higher pore water pressure values compared to the actual instrumentation data. These elevated values are observed in VWPE-11, VWPE-12, VWPF-13, VWPF-14, VWPF-15, VWPE-17, VWPE-19, VWPE-20, VWPE-21, VWPE-23, and VWPE-26 resulting in positive deviations. A negative deviation in VWPF-16 is attributed to the influence of groundwater in the foundation, which causes the vibrating wire piezometer to register water flow as seepage, leading to elevated readings. In addition, the capacity of the vibrating wire piezometer, which can reach up to 500 kPa, may cause rapid increases in pore water pressure under saturated conditions. The negative deviations observed in VWPE-22, VWPE-24, and VWPE-25 are due to the high elevation of these instruments, where no water inflow is present. From the calculated pore water pressure deviations, an RMSE value of 35.26 was obtained. These findings are consistent with a study conducted at Raknamo Dam, East Nusa Tenggara (Kurniawan, 2021), which generally reported that pore water pressure values obtained through the finite element method are higher than those recorded by vibrating wire piezometers. According to the study, the FEM results can serve as a 'safe limit' for assessing the risks posed by excess pore water pressure. A significant rise in pore water pressure beyond this threshold, along with increasing reservoir water levels, may indicate the onset of piping within the dam embankment.

Based on the Figure 6, the relationship between pore water pressure values obtained from actual instrumentation and FEM analysis exhibits a positive correlation. This is indicated by the upward trend of the linear regression line, where pore water pressure values from both FEM and VWP increase concurrently. The results presented in Figure 6 show a correlation coefficient ( $R^2$ ) of 0.89. According to Sugiyono (2016), this value falls within the 'very high' category, indicating a strong relationship between the two variables, with correlation range of 80–100%.

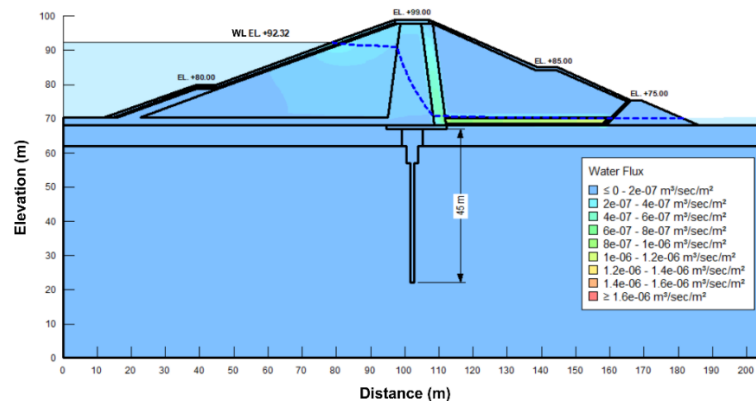
Figure 7. Modeling the addition of upstream impermeable layer

Although the calibration results indicate that the seepage discharge falls within the safe category, the seepage estimated from the FEM analysis is relatively high, with a value of 0.01271 m³/sec, which may potentially lead to piping. Therefore, as a precautionary measure against the risk of excessive seepage as predicted by the model, 2 (two) technical recommendations are proposed for implementation in the event of an increase in actual seepage discharge.

The installation of an upstream impermeable layer can extend the seepage flow, thereby reducing the seepage rate. Based on the FEM analysis results (Figure 7), such an installation can decrease seepage discharge by approximately 0.00661 m³/sec or 52%, from the original value of 0.01271 m³/sec at a reservoir

water level elevation of +92.32 m in STA B12 to 0.0061 m<sup>3</sup>/sec. This reduction is achieved when the permeability coefficient of the upstream impermeable layer is equal to the core zone, at  $4.59 \times 10^{-6}$  cm/sec.
