Material Characteristics and Failure Prediction of SA 213 Superheater Boiler Tube in Power Plant with 315 MW Capacity

Abstract

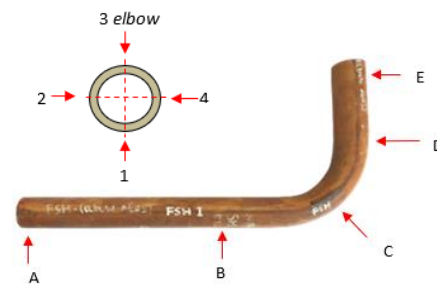
The thickness calculation was measured based on the following locations as shown in Figure 1. The average thickness was 8.15-8.25 mm in all locations, except for the elbow location where the thickness was recorded with only 7.01 mm. this thinning indicates that the thickness of the elbow from boiler tube have thinner than other locations.

Figure 1. Thickness measurement of the boiler tube (left), and the location of measurement (right)

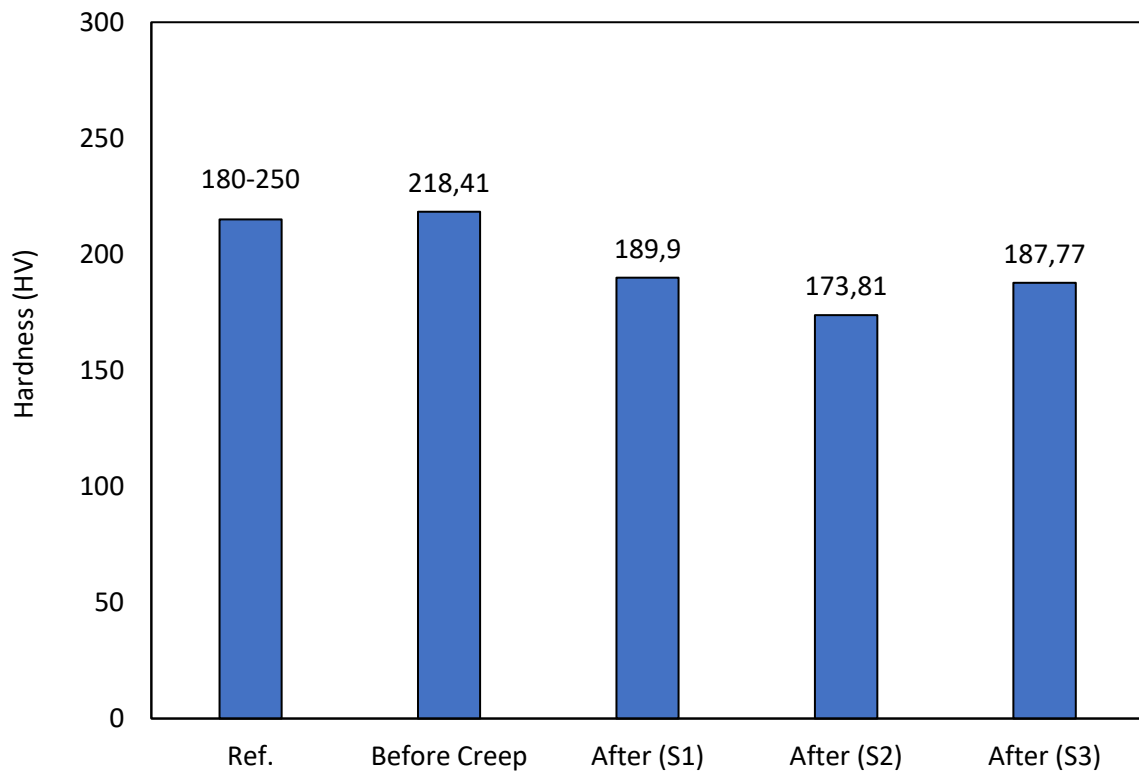
Further analysis related to the hardness of the tube are applied for the boiler tube that facing temperature 750°C and 800°C in the actual operation. The results of hardness compared to the specimen before creep and references can be seen in Figure 2. The ref. hardness was captured from previous work [15], where the steel before applied with creep test was listed as before creep. The results of hardness showed that the hardness fallen for all samples where it applied with heat treatment. The decreased of hardness also indicate the reduce of the mechanical properties of the materials.

Figure 2. Hardness measurement before and after creep test

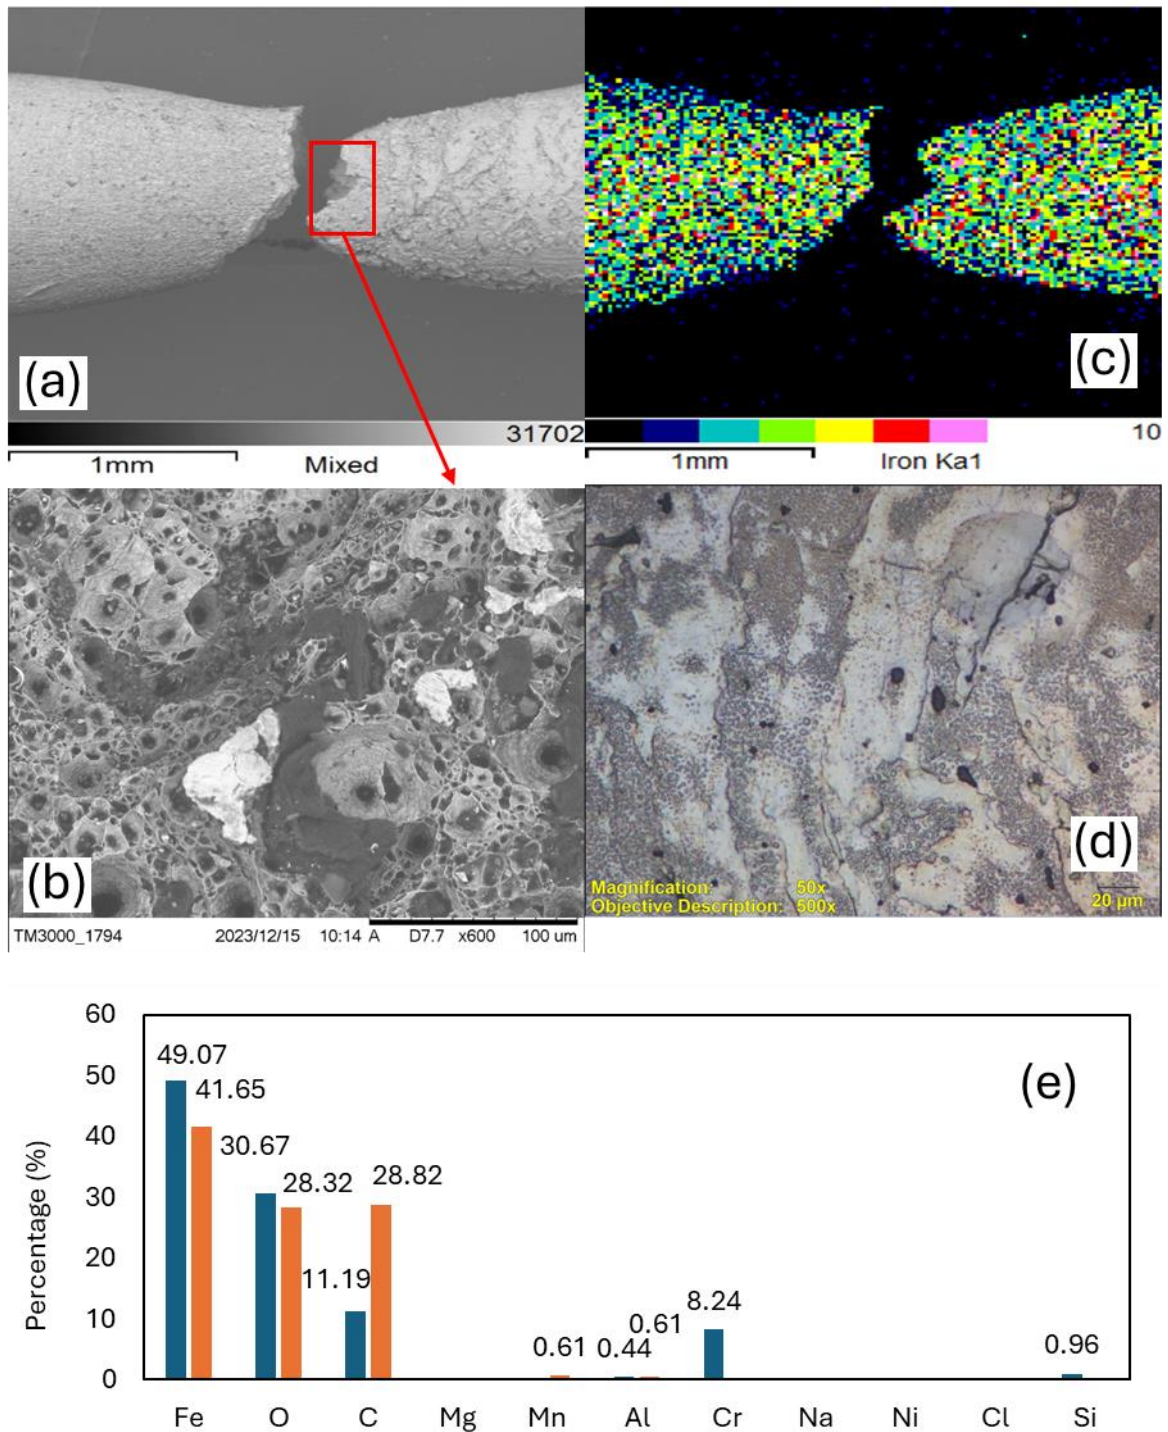
Figure 3. SEM analysis of specimen (a-c), (d) Metallography analysis of fractured specimen, (e) Chemical composition of sample exposure of 800°C temperature

After failure, specimen then applied SEM-EDS analysis and metallographic evaluation as seen in Figure 3. The fracture area recorded using SEM as seen in Figure 3 (a) where the macro scale presented. The Fe composition also indicated as seen in Fig. 3 (b) followed by micro-scale SEM image are presented in Figure 3 (c). the metallographic image that shown in Figure 3 (d) indicated that the crack and void are presented. The metallography image indicated that the effect of temperature and time exposure triggered crack propagation and void occurred in the surface of the specimen. Chemical composition of the specimen is reflected in Figure 3 (e) where the oxidation was severe occurred on the surface of the materials and triggered with void occurrence and trans granular cracks.
