Statistical Analysis of Short-Term Shoreline Change Behavior Along The Southern Cilacap Coasts of Indonesia

Coastal Dynamics, Shoreline Change Rate, Erosion, Accretion, Cilacap

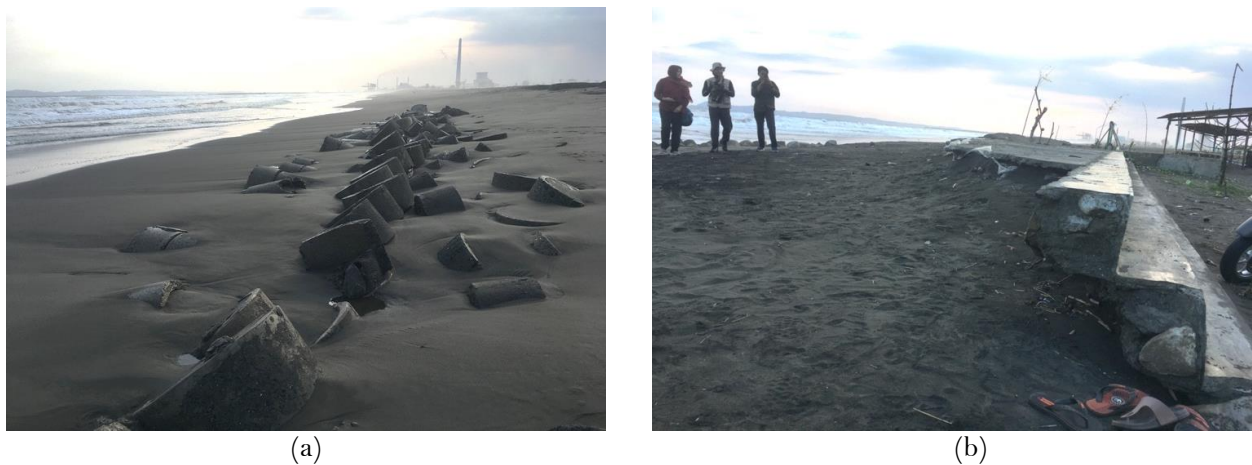
Figure 1. a) The Traditional Breakwaters and Hard-Structures that are Broken due to Erosion; and
b) A Broken Jogging Track Following The Erosion

One of Indonesia's coastal areas is Cilacap Regency, Central Java Province, which is located in the south of Java Island so that it directly faces the Indian Ocean, which has the characteristic characteristics of large waves, high water salinity, and diverse sediment substrate composition (Budiadi, 2020). This position makes Cilacap Regency have the potential for floods, landslides, tsunamis, and coastal erosion disasters in coastal areas. Based on the 2017–2022 Regional Medium Term Development Plan of Cilacap Regency, the target for disaster-resilient villages in Cilacap Regency has only reached 7.04% of the total villages. The threat of coastal erosion in Cilacap Regency occurs in five sub-districts, one of which is Adipala District. It is further specified that there is a threat of extreme waves and a moderate risk level of coastal erosion in 23 villages, one of which is Bunton Village. Based on a preliminary visit and an interpretation of the satellite imagery in Google Earth, it can be seen that there is huge erosion of the shoreline and visible changes in the shoreline temporally (Figure 1).

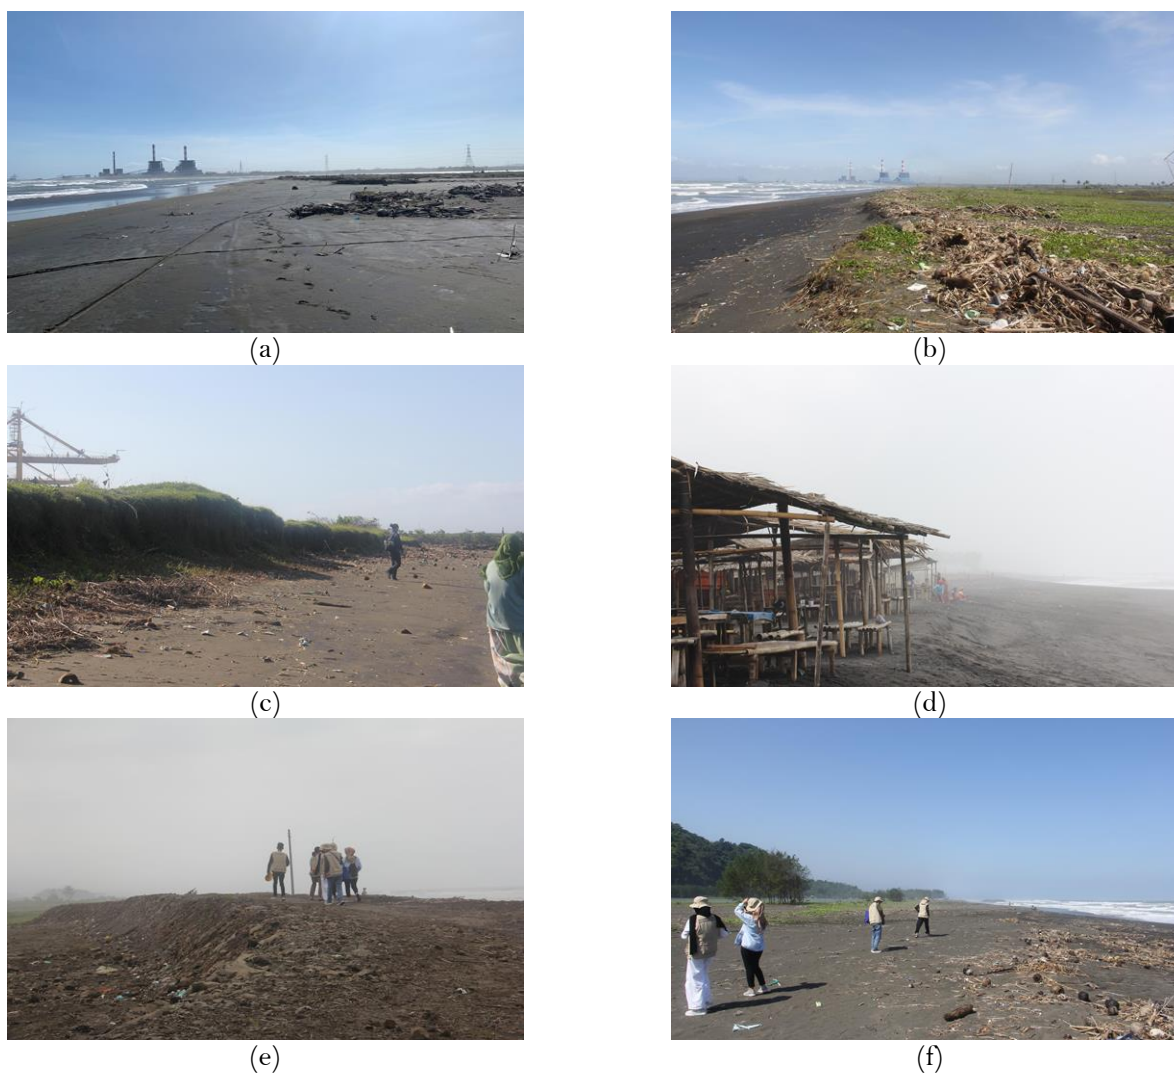
Figure 6. Present Condition Along the 100-meter Cross-Sectional Profile at Cross-Profile 1 (a) to 6 (f) that Experience Massive Erosion along Bunton Coastal Area

form of erosion. The erosion process occurs at a rate of -32.9 meters per year, with a change distance of -657.92 meters. At this location, there are 57 meters of undeveloped, unplanted land from the coast to the river. At high tide, seawater inundates the beach at this location (Figure 6a), potentially leading to environmental issues such as marine debris (Isnain & Mutaqin, 2023; Wahid & Mutaqin, 2024; Hibatullah & Mutaqin, 2024). Conditions near river estuaries cause changes in shorelines (both erosion and accretion) that are very dynamic because they depend on the amount of river water supply, transported sediment material, climate, wave activity, tidal waves, and currents (Bird, 2008; Ningsih & Mutaqin, 2024; Widantara & Mutaqin, 2024).

Cross-profile 5 (Figure 5e) is associated with transect 70, which experienced erosion with a rate of -13.95 meters per year and a change distance of -279.01 meters. Hard rock structures that can withstand waves serve as a limit to the difference in beach elevation and empty land (Figure 6e). Even though the hard rock structure can withstand wave energy, coastal conditions directly facing the sea will become increasingly eroded, increasing the potential for seawater intrusion (Zamroni et al., 2021; Putriany & Sejati, 2023; Ningsih & Mutaqin, 2024; Widantara & Mutaqin, 2024; Purnama et al., 2024). Cross-profile 6 (Figure 5f) is associated with transect 89, which also experienced coastal erosion. This area has an erosion rate of -5.22 meters per year and a change distance of -104.34 meters. This area has almost the same conditions as cross-profile 1 (Figure 5a), which is dominated by empty land, but vegetation in the form of grass and *Casuarina equisetifolia* is found in the middle (Figure 6f). Apart from coastal erosion, other issues in this area include marine debris, which is also similar to environmental problems faced by Yogyakarta province (Isnain & Mutaqin, 2023; Wahid & Mutaqin, 2024; Hibatullah & Mutaqin, 2024). Shoreline dynamics in proximity to river estuaries are influenced by various factors, including the quantity of river water supply, transported sediment material, climate conditions, wave activity, tidal waves, and currents (Bird, 2008; Ningsih & Mutaqin, 2024; Widantara & Mutaqin, 2024). These conditions give rise to both erosion and accretion processes, which exhibit a high degree of dynamism.
