International Journal of Science and Engineering(IJSE)

Soil Erosion Assessment of The Post-Coal Mining Site in Kutai Kartanagera District, East Kalimantan Province

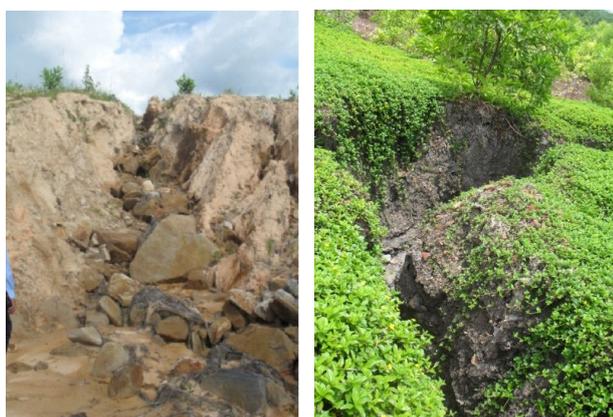
Figure 2. Soil erosion at post coal mining site in Kutai Kartanegara district

Erosion that occurred at reclaimed site was higher than the tolerable soil loss (Table 8). Concerning to the shallow solum of the land, this condition was very dangerous as the soil was continually eroded and loss within short time.

The research showed that erosion magnitude during the first month of reclamation age was 4.810,4 ton ha⁻¹ while other companies showed that until four month the erosion magnitude was 4,966.3 ton/ha. This indicated that reclamation carried out by several companies was very bad. Meanwhile, erosion magnitude could only be reduced by 1.9 ton/ha/year for companies who had good reclamation program. Inadequate reclamation action could be seen from erosion magnitude at nine year age of reclamation i.e. 201.1 ton/ha/year. Adequate reclamation action with good vegetative cover could be seen from erosion magnitude at five year reclamation age i.e. 1.7 ton/ha/ year.
