Dry Landslide in Sarwodadi Village, Pejawaran Sub-Regency; An Untypical Landslide in Banjarnegara Regency, Central Java Province, Indonesia

Citation: Lisan, A. R. K., Rachman, M. G., Sarastika, T., dan Kurniawan, O. (2025). Dry Landslide in Sarwodadi Village, Pejawaran Sub-Regency; An Untypical Landslide in Banjarnegara Regency, Central Java Province, Indonesia. *Jurnal Ilmu Lingkungan*, 23(2), 359-370, doi:10.14710/jil.23.2.359-370

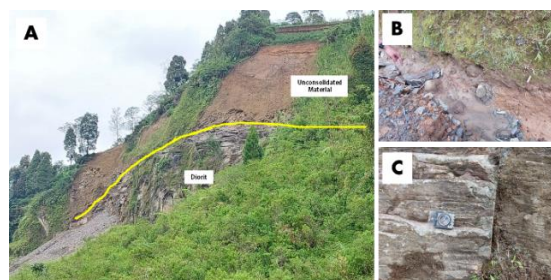
Figure 7. A) Depicts the Stratigraphic Position of the Unconsolidated Unit Overlying the Diorite Unit. (B) Close-up Image of the Unconsolidated Unit Containing Diorite Fragments. (C) Close-up Image of the Fresh Diorite Unit Exhibiting a 'Sheeting-Joint' Structure

Geologically, the study area comprises two main units: the Diorite unit and the unconsolidated material unit (Figure 7A). The Diorite unit, characterized by a brownish-gray weathered surface and a gray fresh color, displays a phaneritic texture with a porphyritic structure in some areas. This unit also exhibits dominant sheeting-joint structures (Figure 7C), which are the result of intense tectonic activity. The unconsolidated material unit, in contrast, consists of loose sediments that include observable fragments of diorite (Figure 7B), suggesting that this unit was deposited after the diorite had already been exposed. The presence of these sheeting joints within the diorite unit is a significant geological feature, as they form due to compressional tectonics, which are also responsible for the observed anticline structures in the area (Figure 8). Additionally, the fault and fracture systems, observed at various sites during field investigations, further indicate the presence of tectonic activity. These geological characteristics are crucial in assessing the stability of the slopes and understanding the mechanisms that may contribute to landslides in the region (Table 2).

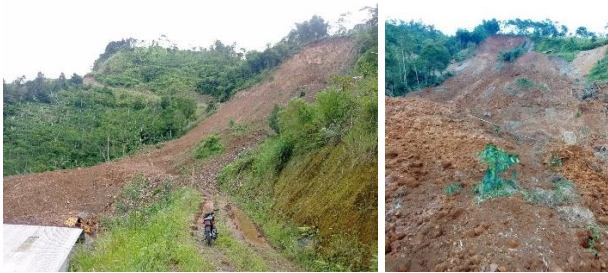
Figure 9. Landslide Condition in Sarwodadi, Pejawaran, Banjarnegara

The landslide that occurred in Sarwodadi Village, Pejawaran Sub-regency, Banjarnegara Regency, on July 6, 2022 (Figure 9), took place at approximately 10:30 PM.

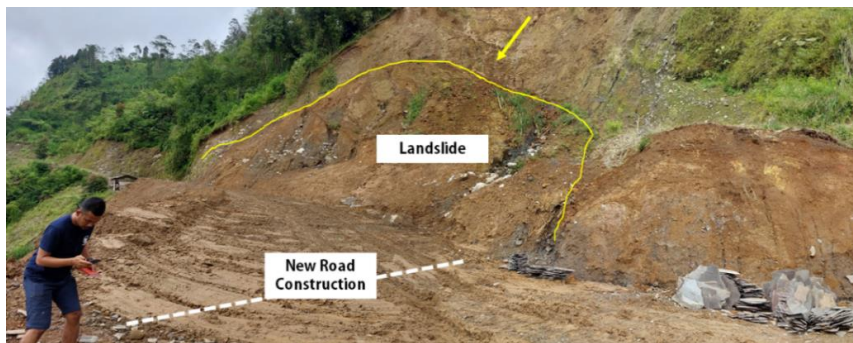
Figure 10. Photo of the Landslide Location at the New Road Construction

One of the key geological factors contributing to this landslide was the loss of structural support from a stress barrier due to road construction activities. The site is characterized by a diorite rock formation that is utilized by local miners for ornamental stone, collected manually and transported. To facilitate these activities, a new road was constructed, which required excavation of the diorite unit, leading to a critical loss of slope stability. This loss of support can be attributed to two interrelated processes: the removal of the stress barrier and subsequent mass shear, as illustrated in Figure 10 and 11.
