# Improvement of Pitting Corrosion Resistance in Type 201 Stainless Steel by Electrochemical Method in Nitric Acid Solution

Pitting Corrosion; Stainless Steel 201; Surface Treatment; Cyclic Voltammetry; Nitric Acid

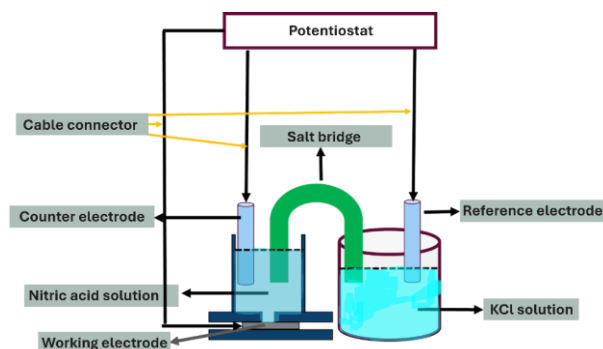
Figure 1. Schematic of surface treatment process

Surface treatment was carried out using two methods: cyclic voltammetry and immersion. The cyclic voltammetry method involved immersing the SS201 samples for 60 minutes with 50 scan cycles, as illustrated in Figure 1. The immersion method also involved a 60-minute treatment in nitric acid without electrochemical cycling. Following surface treatment, the samples were analyzed using an optical microscope and SEM-EDS to observe surface morphology and elemental distribution. Corrosion testing was then performed using open-circuit potential (OCP) and anodic polarization techniques. After the corrosion tests, the sample surfaces were re-examined with a microscope to evaluate the diameter and depth of pitting corrosion that developed on the SS201 surface.

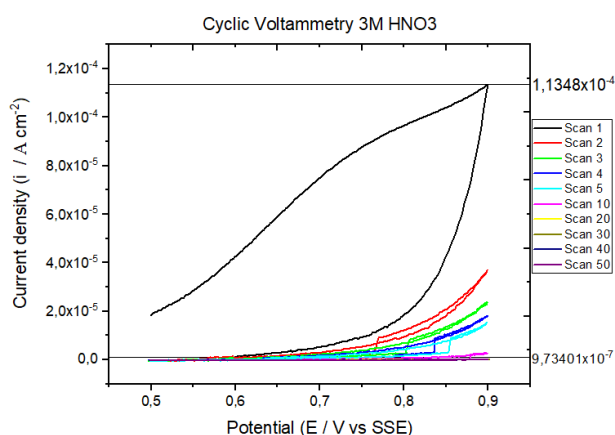
Figure 2. Cyclic voltammetry using 3 M nitric acid

The results of surface treatment with these concentrations are presented in Table 1, where a significant increase in current density was observed during the first CV scan. This increase is attributed to the formation of passive films and the anodic dissolution of constituent metals. In subsequent scans, the current density gradually decreased, indicating stabilization of the passive layer, with consistent reduction observed up to the 50th scan. As shown in Figure 2, the current density at 0.9 V was highest for the 3 M nitric acid treatment across all scans, compared to the 1 M and 2 M treatments.

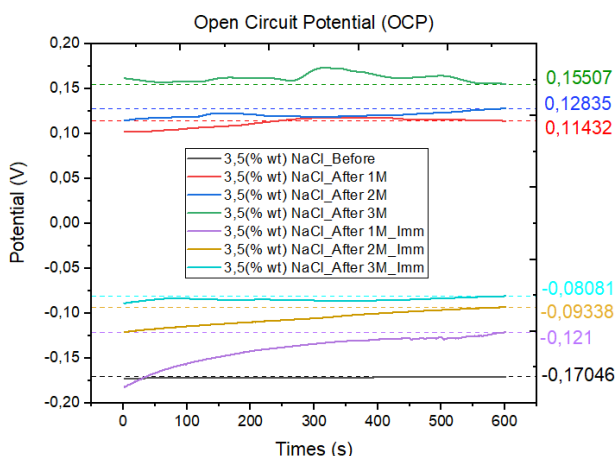
As shown in Figure 3, all specimens exhibited fluctuating OCP curves. SS201 specimens, both treated and untreated, showed more instability in NaCl solution due to chloride ions damaging the passive layer and accelerating surface degradation. This was consistent with the pitting analysis, which indicated more severe damage in untreated specimens. The surface damage caused by NaCl created irregularities and gaps, making the specimen surfaces uneven. As a result, the system required more time to reach electrochemical stability before corrosion testing. This instability contributed to the fluctuating behavior observed in the OCP graphs.

Figure 3. OCP results from SS201 using nitric acid

The results of the OCP test showed variations in potential values across different concentrations. The highest stable potential (0.15507 V) was observed in the SS201 specimen treated with 3 M nitric acid using cyclic voltammetry, while the lowest (-0.17046 V) was recorded in the untreated specimen.

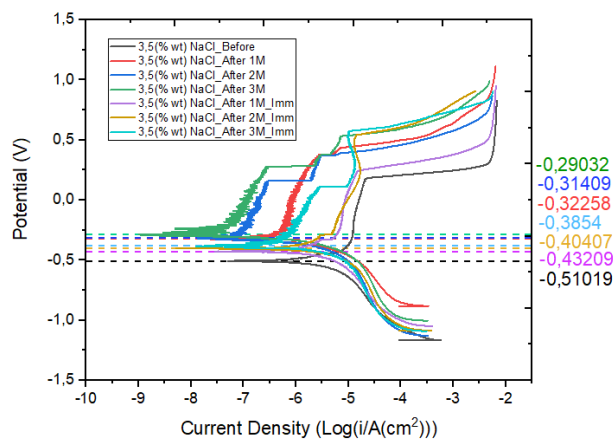
Figure 4. The polarization curve of SS201 after nitric acid surface treatment

Following the OCP test, corrosion testing was conducted using the anodic polarization Tafel method with an Autolab potentiostat to obtain Tafel plots, from which the corrosion potential ( $E_{\text{corr}}$ ) and corrosion current density ( $I_{\text{corr}}$ ) values were determined. The experiment was performed in a 3.5 wt% NaCl solution. The linear sweep voltammetry (LSV) curves, shown in Figure 4, illustrate the results of the anodic polarization test. In the NaCl solution,  $E_{\text{corr}}$  values varied depending on the surface treatment applied. Untreated specimens exhibited an  $E_{\text{corr}}$  of -0.51019 V, while specimens treated by immersion in 3 M nitric acid showed an improved  $E_{\text{corr}}$  of -0.29032 V. These results indicate that increasing the concentration of the surface treatment enhances the corrosion resistance of SS201 in the corrosive NaCl environment. The  $I_{\text{corr}}$  values were obtained by analyzing each Tafel curve using Origin software. The observed fractures correspond to the formation of a new passive film in the second active anodic region, which results from chemical passivation reactions in the nitric acid solution. The details from Figure 4 are presented in Table 2.

The anodic polarization Tafel test generates forward and reverse curves, which are used to determine the pitting potential ( $E_{\text{pitting}}$ ) and repassivation potential ( $E_{\text{repassivation}}$ ).  $E_{\text{pitting}}$  is the potential at which pitting corrosion begins on the specimen surface due to NaCl exposure, while  $E_{\text{repassivation}}$  is the potential at which the surface starts to heal or repassivate after the damage. The difference between  $E_{\text{pitting}}$  and  $E_{\text{repassivation}}$  indicates the potential range needed for recovery, reflecting the surface's ability to repair itself after corrosion.

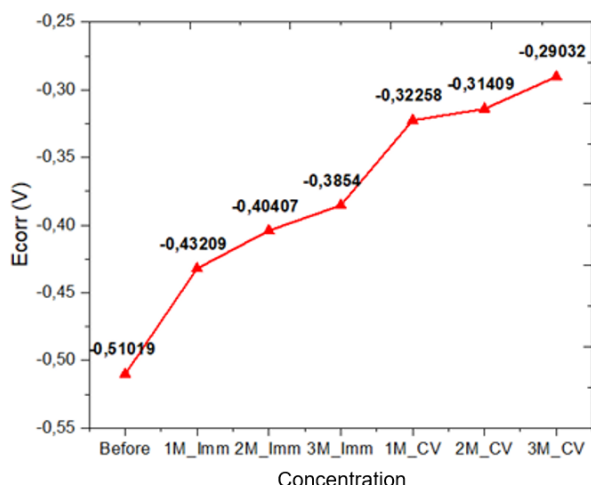
Figure 5. The  $E_{corr}$  for immersion and cyclic voltammetry surface treatment

Figure 5 compares the  $E_{corr}$  of SS201 in a 3.5 wt% NaCl solution under different surface treatments. The untreated specimen exhibits the most negative  $E_{corr}$  value ( $-0.51019$  V), indicating high corrosion susceptibility. In contrast, specimens treated via immersion and cyclic voltammetry exhibit a positive shift in  $E_{corr}$ , suggesting improved corrosion resistance. This trend becomes more pronounced with increasing nitric acid concentrations from 1 M to 3 M, especially in immersion-treated samples, which show more consistent improvement. The shift toward less negative potentials indicates the formation of a protective passive layer that limits anodic dissolution. The 3 M immersion treatment achieves the most favorable  $E_{corr}$ , demonstrating the highest effectiveness among all conditions tested.

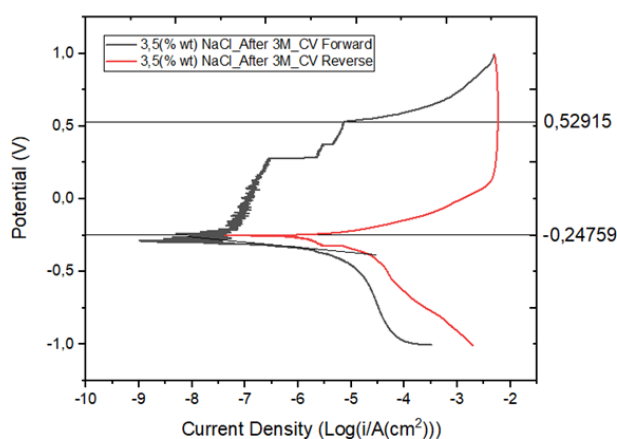
Figure 6. Forward and reverse Tafel polarization curves

Analysis of the  $E_{pitting}$  and  $E_{repassivation}$  further supports these findings (Figures 6 and 7). The highest  $E_{pitting}$  value,  $0.57612$  V, was observed in the specimen treated by 3 M immersion, indicating strong resistance to pitting corrosion initiation. The highest  $E_{repassivation}$  value,  $-0.1748$  V, was found in the 2 M treated specimen, reflecting effective surface recovery. Conversely, the lowest  $E_{pitting}$  value,  $0.17445$  V, occurred in the untreated specimen, and the lowest  $E_{repassivation}$  value,  $-0.25396$  V, was observed in the 1 M immersion specimen. The potential difference ( $\Delta E$ ) between  $E_{pitting}$  and  $E_{repassivation}$  reflects the recovery time required after pitting corrosion occurs.

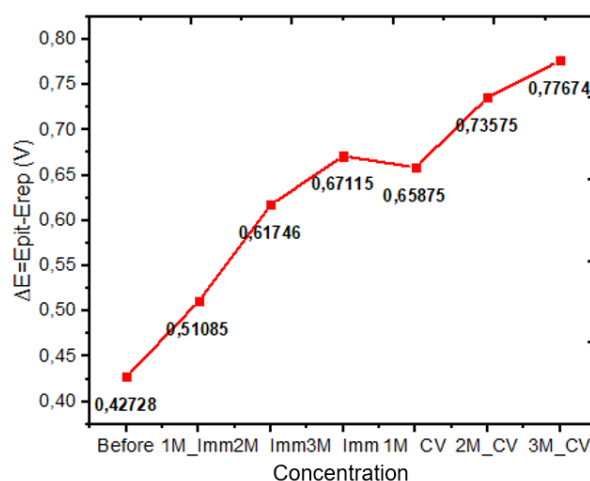
Figure 7.  $E_{pitting}$  and  $E_{repassivation}$  curve

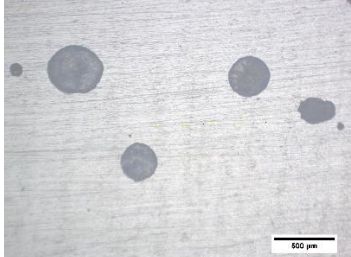
Table 4. Microscopic visuals

Macrostructure and microstructure analyses, summarized in Tables 3 and 4, reveal distinct areas affected by pitting corrosion in SS201. A clear difference is observed between specimens with and without surface treatment. In the 3.5 wt% NaCl solution, pitting holes are prominently visible. While all specimens exhibited pitting corrosion, those without surface treatment showed significantly larger and more numerous pits compared to treated samples. Corrosion testing using the anodic polarization Tafel method further supports these findings, demonstrating that untreated specimens exhibit the lowest  $E_{corr}$  values, indicating greater susceptibility to corrosion.

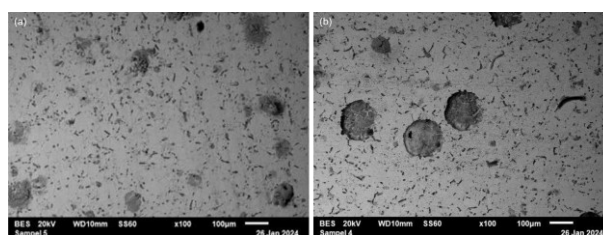
SEM-EDS analysis revealed notable differences in the surface morphology and elemental composition of SS201 before and after nitric acid surface treatment, as shown in Figure 8. Prior to treatment, the surface was relatively uniform with no significant topographical damage. Elements such as Fe, O, Ni, Cr, and Cl were evenly distributed, indicating a homogeneous passive layer without evident localized corrosion.

**Figure 8.** SEM images of the SS201 surface: (a) before surface treatment and (b) after surface treatment with nitric acid

After treatment with nitric acid, pitting corrosion was still present but significantly reduced in both severity and density compared to untreated specimens. SEM-EDS results (Figure 9) showed that Fe, O, Ni, Cr, and Cl remained detectable, particularly in the pitted regions. The enrichment of Ni and Cr in these areas is important, as these elements promote the formation and stabilization of protective passive films, enhancing corrosion resistance. The presence of compounds such as FeCl, NiO, Cr<sub>2</sub>O<sub>3</sub>, and ferric hydroxides suggests that chemical reactions between nitric acid and the stainless steel surface contributed to the development of oxide and hydroxide layers. These layers act as barriers against chloride attack, lowering surface reactivity and inhibiting the progression of pitting corrosion.

Chromium plays a key role in forming the Cr<sub>2</sub>O<sub>3</sub> film, while nickel improves the alloy's resistance in acidic and chloride-rich environments, resulting in a more corrosion-resistant surface. Although some pitting corrosion remains, nitric acid surface treatment clearly inhibits its development. The treated surface exhibits enhanced resistance to chloride-induced damage, demonstrating the effectiveness of nitric acid in modifying surface chemistry to favor passivation. Thus, while corrosion is not completely eliminated, it is substantially mitigated, producing a more stable and less damaged surface.

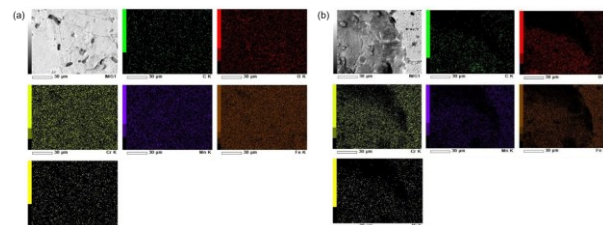
**Figure 9.** EDS images of SS201 surface: (a) before and (b) after surface treatment
