# Concrete Jacketing for Strength Enhancement of Square Columns in Corroded Reinforced Concrete Structures

*Buildings submerged during the 2004 Aceh tsunami have shown signs of structural degradation, particularly due to corrosion in column reinforcement, raising concerns about reduced seismic performance. This study aims to evaluate the effectiveness of the concrete jacketing method in retrofitting corroded square reinforced concrete columns. Specimens measuring 200 × 200 mm<sup>2</sup> in cross-section and 580 mm in height were subjected to accelerated corrosion targeting 20% mass loss, followed by axial and lateral loading tests. The results showed that corrosion reduced shear strength by 23.93% compared to non-corroded specimens. However, retrofitted corroded square reinforced concrete column demonstrated a 15.65% increase in strength when the stirrup reinforcement yielded. However, the shear capacity showed a slight decrease compared to the corroded columns without jacketing. This unexpected reduction is attributed to the absence of joint strengthening in the retrofit, which governed the overall shear resistance. These findings highlight the importance of including joint enha

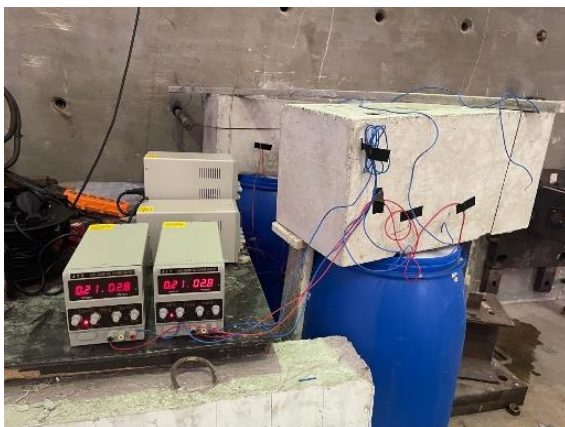
Figure 2. Accelerated corrosion test.

The column specimens were submerged in a seawater tank during the accelerated corrosion test. The seawater was sourced from the Alue Naga coastal area in Banda Aceh (latitude 5.6034220, longitude 95.3475060). The corrosion test setup is shown in Figure 2. The seawater acted as an electrolyte, providing chloride ions (Cl<sup>-</sup>) necessary for the electrochemical corrosion process. The reinforcement bars were connected to a direct current (DC) power source, while a copper plate was submerged in the seawater solution. The reinforcement bars and the copper plate served as

the anode and cathode, respectively. Throughout the test, a constant current of 0.21 A was maintained. The targeted corrosion level was achieved based on mass loss, with a desired mass reduction of 20%. The estimated test duration, calculated using Faraday's law, was 21 days.

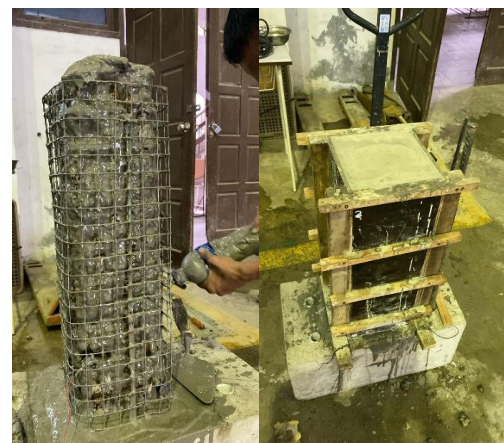
Figure 3. Retrofitted specimen.

After the corrosion test was completed, the concrete cover of specimen C-10-R was removed, and retrofitting was carried out as shown in Figure 3. A wire mesh was installed around the longitudinal reinforcement, and a bonding adhesive was applied to the surface of the existing concrete after chipping off the original cover. The concrete cover of the column was then recast using concrete with a compressive strength of 30 MPa.

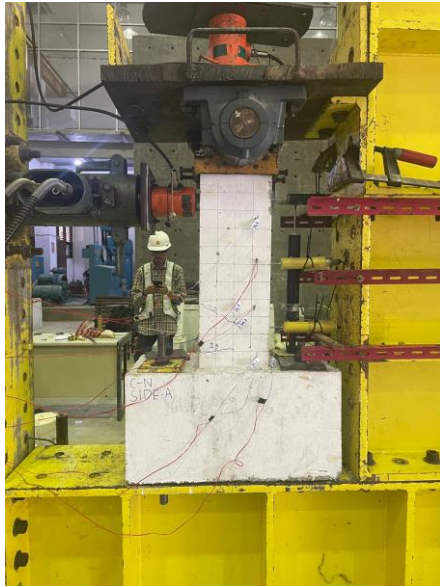
**Figure 4.** Test set-up.

During the testing phase, the square RC column specimens were rigidly fixed to a steel reaction frame, as illustrated in Figure 4. The square RC columns were subjected to both axial and lateral loading. A constant axial compressive load of 100 kN was applied throughout the test, while the lateral load was gradually increased until the specimen reached its ultimate load capacity and experienced failure. All measuring instruments, including displacement transducers, strain gauges, and load cells, were connected to a data logger to record load variations throughout the test. The lateral deflection of the columns was measured using displacement transducers placed at heights of 100 mm, 300 mm, and 500 mm from the column base. The loading process was terminated once the lateral load began to decrease, indicating structural failure. Crack propagation was monitored during the test, and the final crack patterns were documented for each specimen.

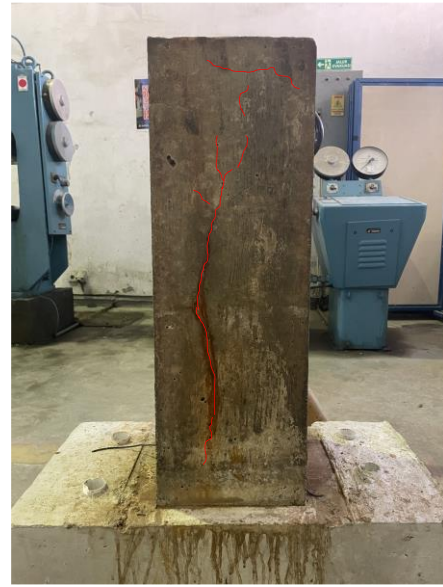
**Figure 5.** Condition of specimens after corrosion testing.

Figure 5 shows the condition of the test specimens after 21 days of accelerated corrosion testing. Cracks on the concrete surface are indicated by red lines. Corrosion in reinforced concrete is an electrochemical process. When the chloride ion concentration in the concrete exceeds a certain threshold, the protective oxide layer on the steel reinforcement is compromised. During the corrosion process, the corroded part of the reinforcement acts as the anode, while the surrounding uncorroded areas serve as the cathode. Electron flow from the anode to the cathode reacts with hydroxide ions ( $\text{OH}^-$ ), generating an electric current and forming  $\text{Fe}(\text{OH})_2$ . The reddish or brown-orange color corrosion products result from subsequent reactions with oxygen and water penetrating the concrete. This phenomenon has also been described by (Amalia et al., 2018). It was observed through SEM, reported that corrosion products in brown-orange color penetrated along the full length of vertical cracks on the rebar surface, while smaller cracks (0.006–0.011 mm) showed minimal visible corrosion products. SEM images further revealed that corrosion products, often appearing white due to higher density, tended to fill the cracks rather than the surrounding concrete pores. In this study, several reddish or brown-orange corrosion

products were observed near the cracks shown in Figure 5. Such corrosion leads to a reduction in steel mass, which is quantified based on the mass loss relative to the wet surface area of the reinforcement.

Surface cracks on the concrete were observed as a result of reinforcement corrosion. The cracks followed the path of the reinforcement, in agreement with the findings reported in (Amalia et al., 2021).

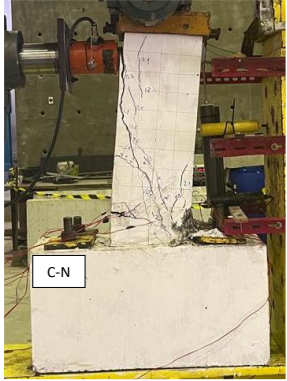
Table 4 presents the crack patterns and failure modes observed in the three column specimens. The failure mode of specimen C-N was classified as shear-flexure. Flexural cracks first appeared at a load of 4.3 tons on the tension side of the column. As the shear load increased, diagonal shear cracks developed along the sides subjected to shear forces. However, failure ultimately occurred due to the widening of the flexural cracks.

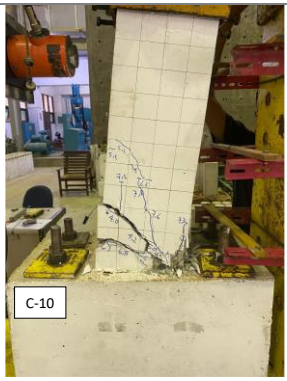
In specimen C-10, the initial flexural crack appeared at a load of 4.0 tons. Compared to C-N, this represents a 0.3-ton reduction in initial cracking load. Specimen C-10 experienced a flexural failure without the presence of shear cracks. Corroded square RC column tend to exhibit earlier flexural failure compared to the shear-flexure failure observed in non-degraded columns. This type of failure was accompanied by more significant deflections before reaching ultimate collapse.

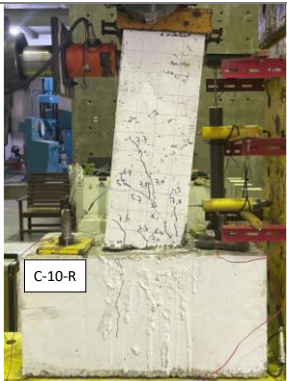
C-10-R

For specimen C-10-R, the first crack appeared at a load of 5.5 tons. Compared to C-N, the initial cracking load increased by 1.2 tons. Shear cracks were observed but did not continue to grow or widen beyond a certain load. This behavior is attributed to the concentration of stress at the column–foundation joint, which eventually became the point of failure.
