## Hydro-acoustic Survey and Edge-detection method in Investigation of a Passenger Vessel Accident in East Java, Indonesia

Hendra Kurnia Febriawan<sup>1\*</sup>, Yudo Haryadi<sup>1</sup>, Aleik Nurwahyudy<sup>2</sup>

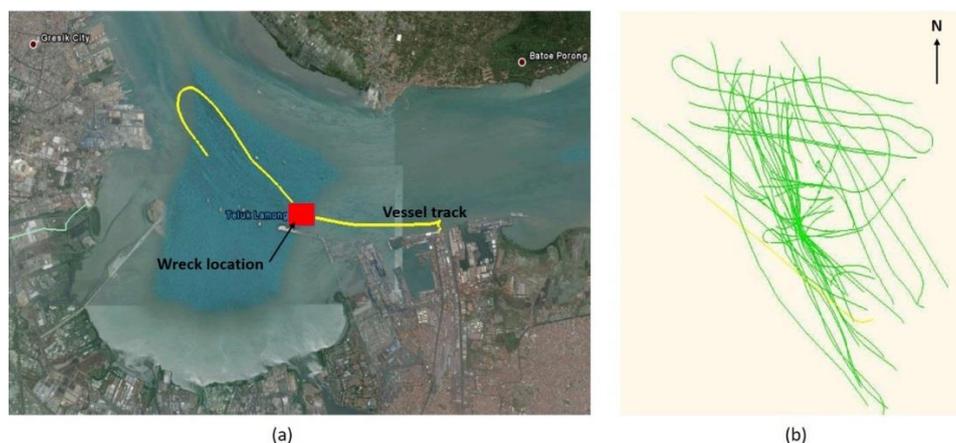
The investigation survey was using MV. Wihan Sejahtera's navigational data which was reproduced from the vessel's AIS data as acquired from the local Vessel Traffic Service (VTS). Following the data, the vessel's track known and be the main reference for the survey. As the survey boat was navigated through the line, the on-line multibeam and side-scan sonar displays were monitored in real-time and recorded the data. The important suspected objects were noted, which then can be examined further. The survey was then focused in the location of the MV Wihan wreck (Figure 3a) and run the lines several times with different directions to get the full-coverage imagery of the wreck (Figure 3b).

**Figure 3.** The survey was then focused in the location  
Note. (a) Navigation tracking of MV Wihan Sejahtera, (b) Survey track line at the wreck location
