## Strength Analysis and Repair Strategy of Aged Steel Jetty Pile

Raditya Danu Riyanto<sup>1\*)</sup>, Nur Syahroni<sup>1)</sup>, Yeyes Mulyadi<sup>1)</sup>

<sup>1)</sup>Department of Ocean Engineering, Institut Teknologi Sepuluh Nopember, Surabaya 60111, Indonesia

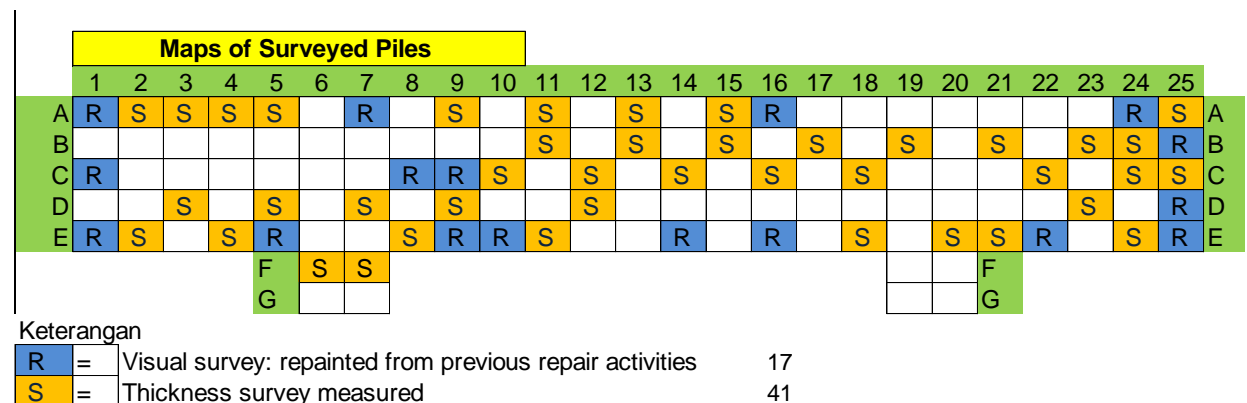
Figure 5. Maps of Surveyed Pile

A visual survey was conducted on all 133 existing piles. It was found that 17 piles were repainted from previous repair activities in 2004. These 17 piles have a relatively fair condition, i.e., no holes due to corrosion occur. The survey then proceeded to the UTM process. The number of jetty piles undertaken by UTM inspection is highly dependent on the budget availability and the inspector's justification. In this case study, the UTM inspection was carried out on 40 piles that experienced the severest corrosion visually. Figure 5 explains piles' location carried out by the UTM survey based on visual surveys.

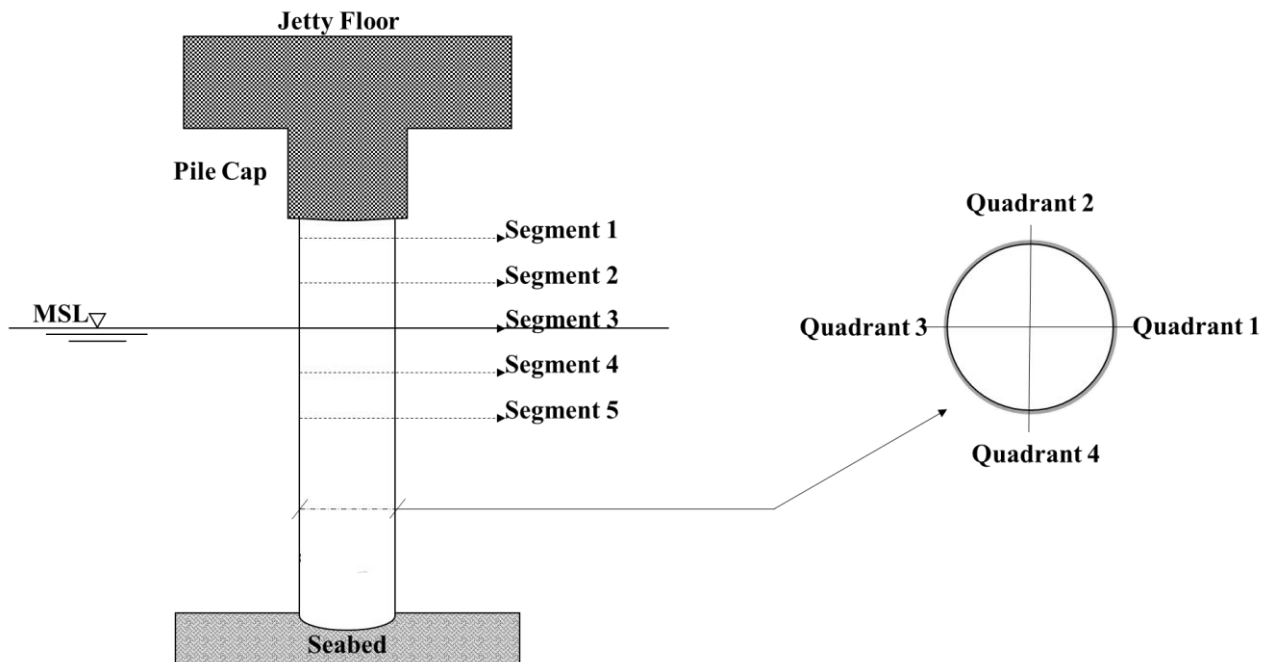
Figure 9. Inspection Measurement Point

Thickness measurements are made at five segment elevation points with each of 4 quadrants at each segment. The selected elevation is 0 m from MSL (Mean Sea Level); 1 m above and below the MSL, 2 m above and below the MSL so that the corrosion conditions in the splash zone can be well-mapped. Figure 9 gives the illustration of the measurement point.

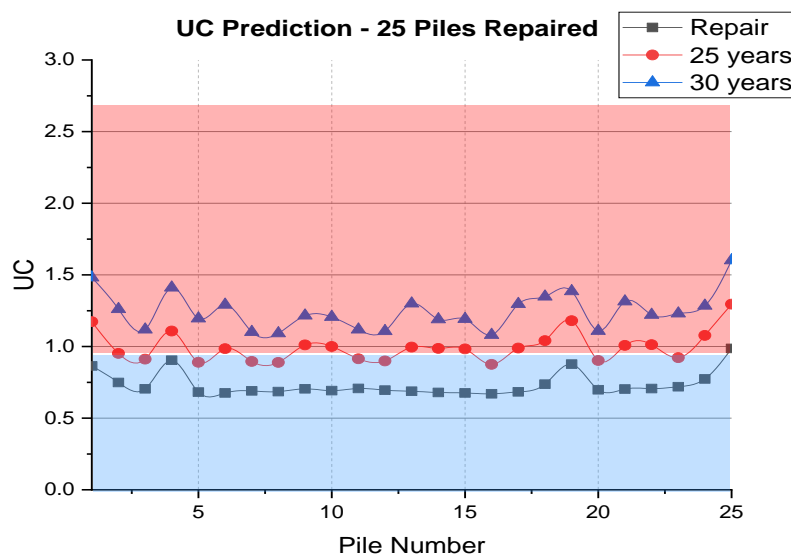
Figure 16. Average jetty piles UC ratio for each row – Scenario 1

The first scenario is to apply repair to 25 damaged piles as per existing structure strength analysis. Figure 16 shows the UC prediction for up to 30 years of service life. The piles' performance declines as the UC increase along with decreasing pile thickness due to corrosion. The chart is divided into two zones, blue and red. The blue zone represents the condition where the  $UC < 1$  and the structure is considered safe. The red zone represents the condition where the  $UC > 1$  and the structures are considered unsafe. The line diagram in black is the UC's condition immediately after repair until the 20th year, assuming the CP is working correctly. It can be observed that all the piles are in the blue zone. The line chart in red shows the UC in the 25th year of operation. It can be seen that some of the piles have  $UC > 1$ , namely piles in row numbers 1, 4, 19, and 25. The blue graphs are for the 30-year corrosion scenarios and are mostly in the red zone, so they are declared unsafe. Thus, with a repair scenario of 25 piles, the structure can last up to 25 years.

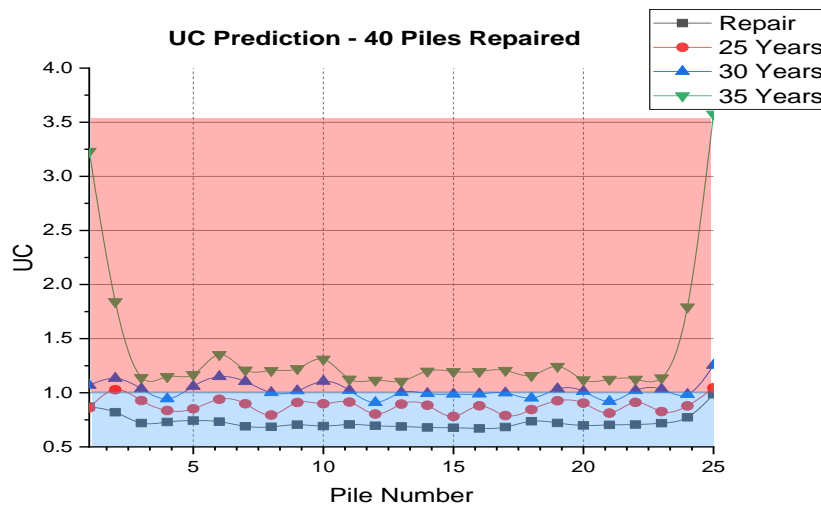
Figure 17. Average Jetty Piles UC Ratio for Each Row – Scenario 2

The second scenario is to apply repair to 40 corroded piles as per existing structural strength analysis. Figure 17 shows the UC prediction for up to 35 years of service life. It can be observed that with a repair scenario at 40 piles, the structure can last up to 30 years. The chart is again divided into blue and red, with the same criteria as Scenario 1. The line black in yellow is the UC's condition immediately after repair until the 20th year, assuming the CP system works correctly.

The red and orange lines are the UC in years 25 and 30, respectively. There are six piles in the red zone. However, they are still within safe limits because the value is below 1.05. In comparison, the green lines are a 35-year corrosion scenario. Most of the UC is in the red zone. Hence, with a repair scenario of 40 piles, the structure could last up to 30 years.

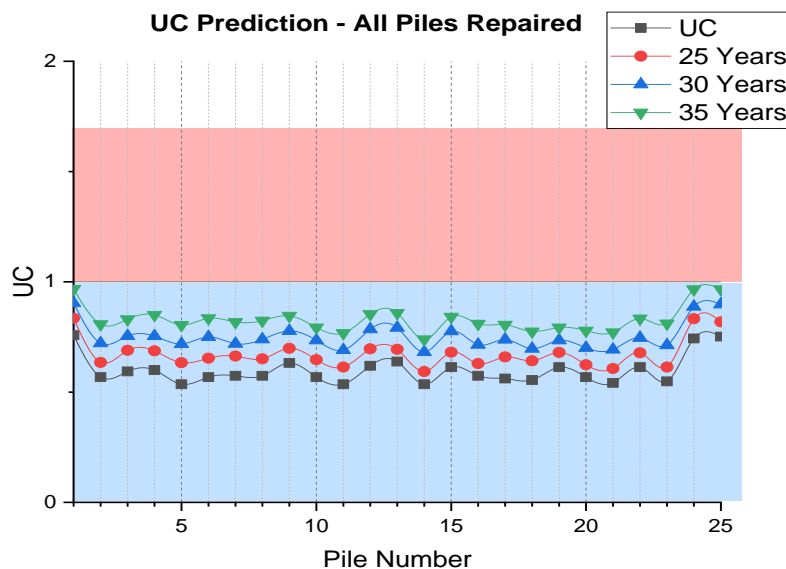
Figure 18. Average jetty piles UC ratio for each row – Scenario 3

The last scenario to be carried out is to repair all 133 piles. It can be observed from Figure 18 the structure can last up to more than 35 years. This scenario is an obvious result looking at the numbers of jetty repairs performed. However, this scenario's best UC result does not represent the best strategy for aged jetty repair. The main factor to select scenario 1, scenario 2, or scenario 3 is the designated duration of jetty life extension.
