EVALUATION OF ACCESSIBILITY AND INCLUSIVE ARCHITECTURE COMPLIANCE AT TAMAN ISMAIL MARZUKI LIBRARY (TIM), JAKARTA

MODUL vol 26 no 1, issues period 2026

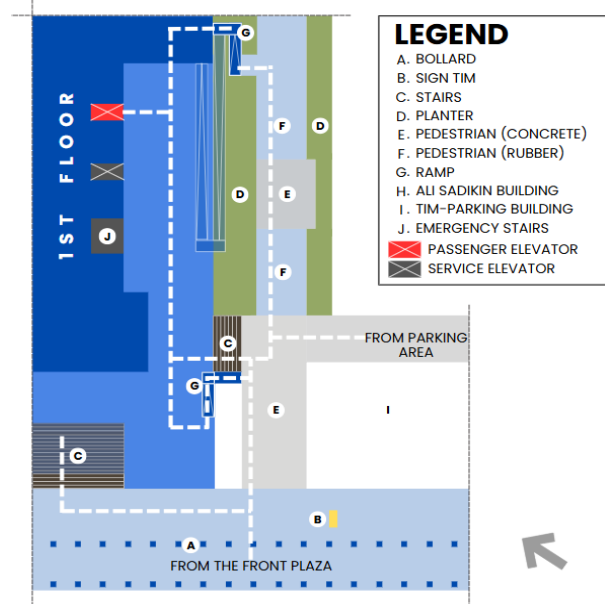
Figure 4. Schematic plan of the 1st floor circulation (Author 2025)

The primary entry point to the library is situated on the third floor, designated for registration and lockers, whereas the main reading areas are found on the fourth and fifth floors. These can be accessed via an elevator or ramp, with the circulation route from the first floor illustrated in (Figure 4). These amenities are crucial in enhancing accessibility and independence for individuals with disabilities. The main pathway leading to the side stairs and entrance measures 5.5 meters in width (Figure 5), which greatly exceeds the SNI 8151:2019 standard, enabling two wheelchair users to pass simultaneously.
