## Post-Fire Ship Hull Repair Method Considering Corrosion Rate and Mechanical Properties

Post-fire,  
ship hull repair,  
corrosion rate,  
3-cell electrode,  
repair method

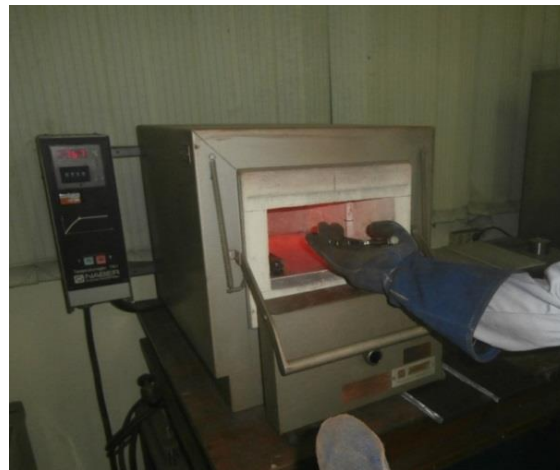
Figure 1. Simulation of burnt ship plates in Furnace

The steel plates were heated in a muffle furnace, as shown in Figure 1, according to the specified elevated temperature variations. Using a direct heating rate method, each target temperature was achieved. Without any holding time when achieving each target temperature, the steel plate was then rapidly cooled by seawater. The steel plates treated at different elevated temperatures are presented in Figure 2, which shows that higher temperatures result in the plates becoming progressively darker in color.

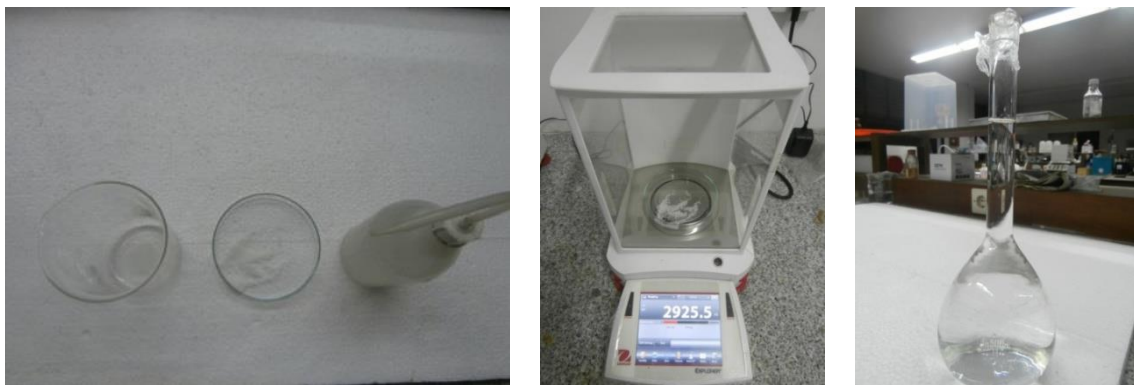
Figure 4. Preparation of electrolyte liquid NaCl 0.1 M

Once the specimens were ready for testing, the next step was to prepare the materials and equipment for the corrosion test. In this experiment, a 0.1 M NaCl electrolyte solution was prepared to conduct the corrosion test using a potentiostat. This electrolyte was made by mixing a specific amount of NaCl powder with distilled water to achieve a 0.1 M concentration. Figure 4 illustrates the preparation process for the materials and equipment used in this experiment.

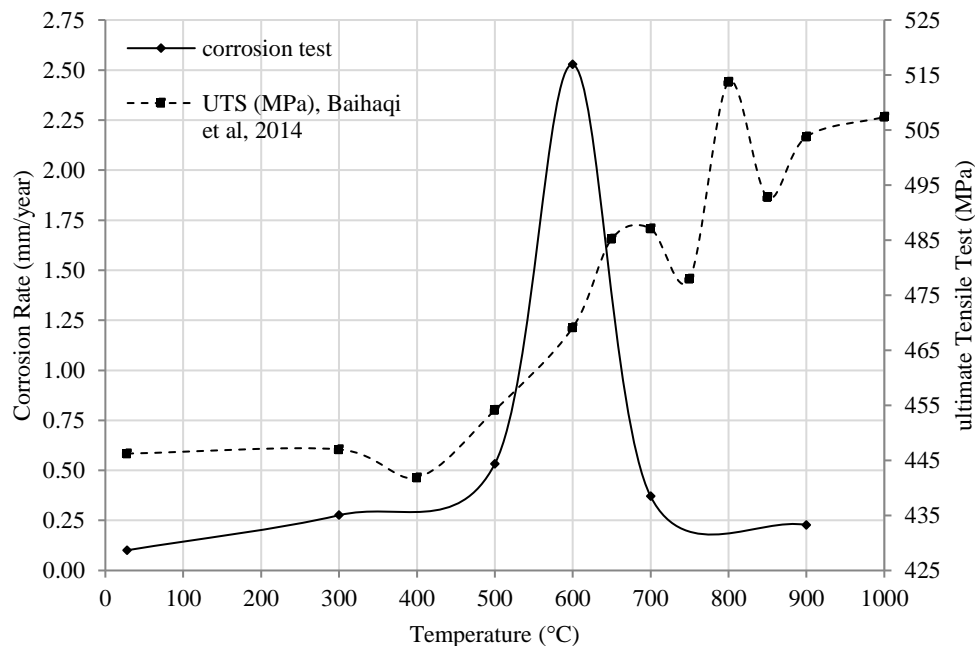
Figure 7. Corrosion rate results based on temperature vs mechanical test according to [9].

A comparison with the mechanical test results reported by Baihaqi et al. [9] reveals a non-linear relationship between corrosion rates and tensile strength. According to Baihaqi et al. [9], the tensile strength of post-fire mild steel plates tends to increase consistently as the temperature rises. In contrast, the corrosion rates show a different pattern: they rise sharply between 500°C and 600°C but then drop significantly between 600°C and 700°C, as illustrated in the Figure 7.

Figure 7 illustrates that the corrosion rate of mild steel increases significantly between ambient temperature and 500°C. Specifically, the corrosion rate roughly doubles at 300°C and becomes five times higher at 500°C. During this temperature range, the ultimate tensile strength remains relatively stable and unchanged, indicating that mild steel is not significantly affected by heat in this range. Additionally, according to the Fe-C (Iron-Carbon) diagram, the low carbon content in mild steel prevents any noticeable changes in its microstructure at temperatures below 500°C.

At 600°C, the corrosion rate of mild steel rises sharply, becoming approximately 25 times higher than at ambient temperature. This significant increase is accompanied by a gradual rise of about 5– 8% in the ultimate tensile strength of the material. However, at 700°C, the corrosion rate drops dramatically, returning to nearly 1/25th of the rate observed at 600°C. During this temperature transition, the tensile strength continues to increase gradually but shows a slight decline at 700°C. This behavior is likely due to temperatures approaching the A1 point, where the microstructure of mild steel begins to change. As a result, the material becomes harder (a process called quenching, which involves rapid cooling), leading to an increase in tensile strength. Meanwhile, the decrease in corrosion rate can be attributed to the enhanced hardness of the steel, which makes it less susceptible to corrosion. At 1000°C, the corrosion rate of mild steel decreases slightly, accompanied by a modest increase in tensile strength. This trend suggests that the material's hardness also improves, which in turn reduces its susceptibility to corrosion and slows down the rate of material degradation. While the increase in tensile strength appears to be a positive outcome, the material's elongation decreases significantly as a result. This reduction in elongation negatively affects the material's toughness and ductility, making it more brittle and less capable of withstanding deformation [23]. In addition, after heating or firing, higher heating temperature led to increase thickness of oxidation on the steel surface because the steel surface interacts with oxygen in elevating temperature and promotes FeO, Fe<sub>2</sub>O<sub>3</sub>, or Fe<sub>3</sub>O<sub>4</sub> in certain layer thickness. After they immersed in seawater, the heated steel surface also interacts with H<sub>2</sub>O that promotes FeOH surface. Those typical passive surfaces may become barriers for the next corrosion test and may reduce corrosion rate.
